Completion of essential repairs and refurbishment at St Eugene's Cathedral

The aim of this project was to carry out essential repairs and maintenance primarily associated with damage caused by the entrance of moisture to the fabric of the building.

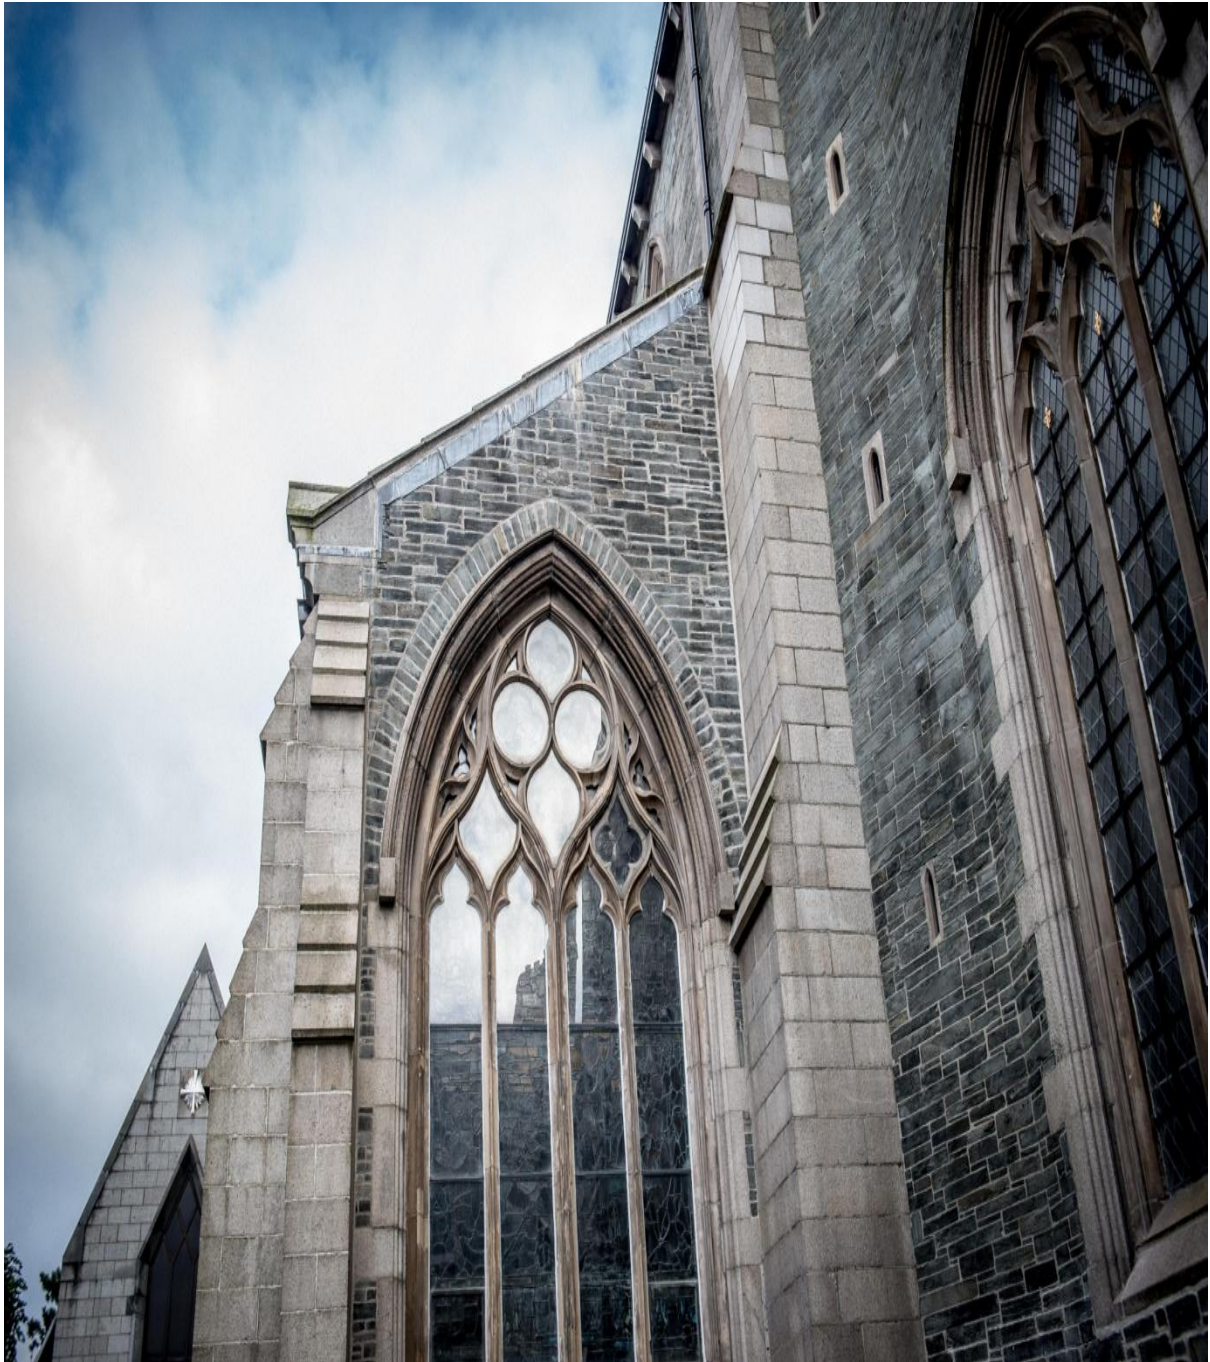
St Columba Window

Damp had been entering this wall via the stone parapet and open joints above the window. The granite parapets and kneeler stone were lifted and new leadwork was installed, along with lime pointing to open joints.

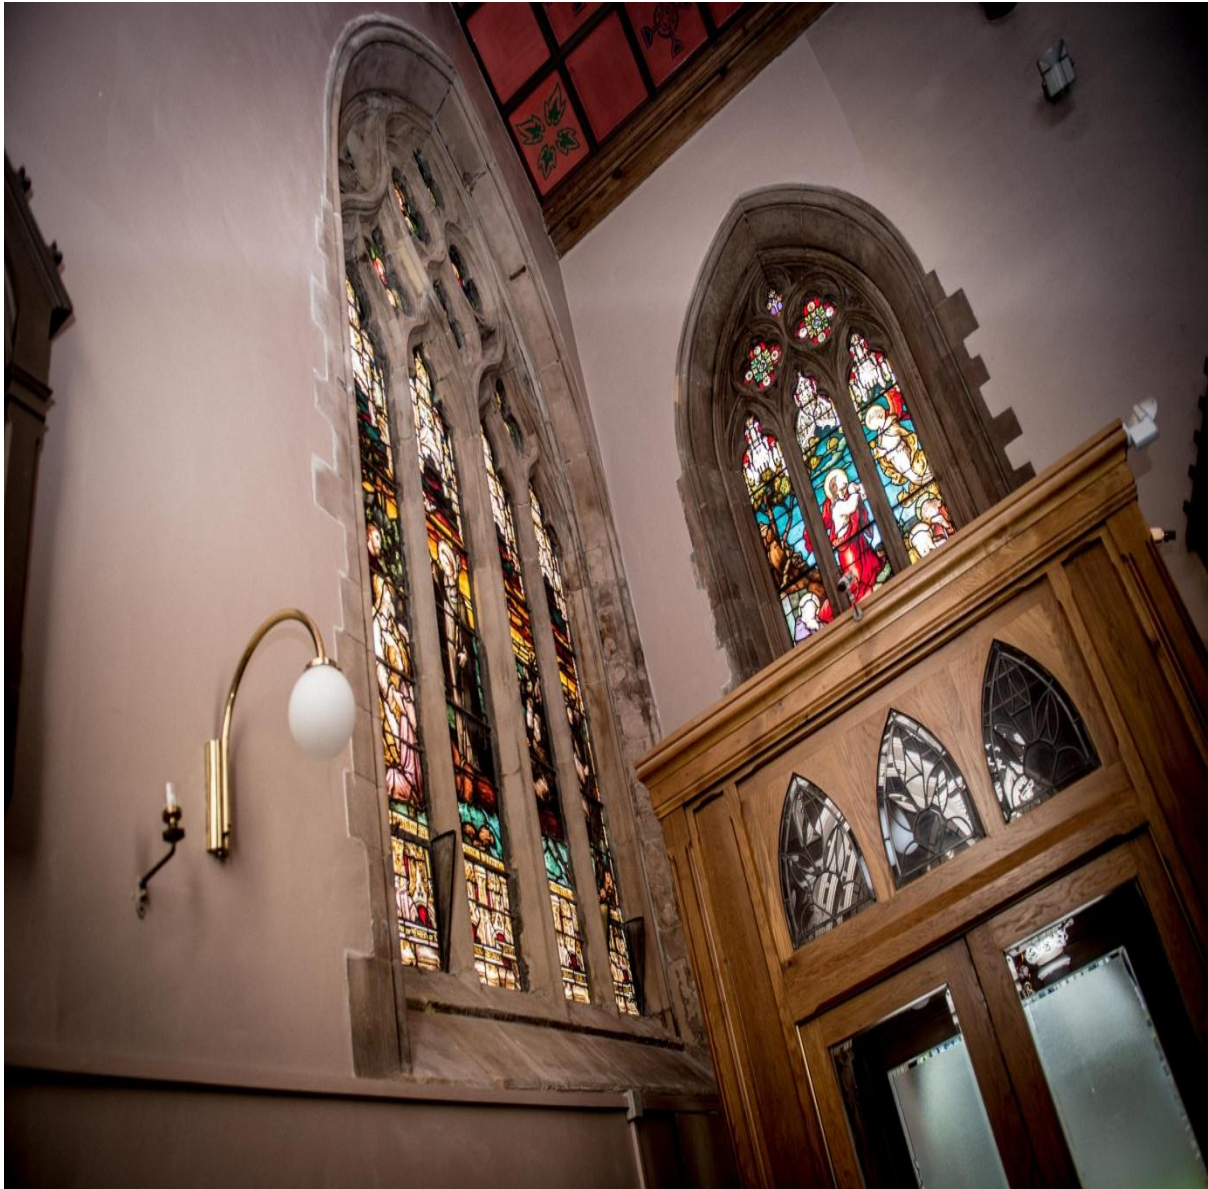
St Columba Window

This window had suffered internal damage from long term damp. New stone sections were inserted to replace damaged tracery and reveals.

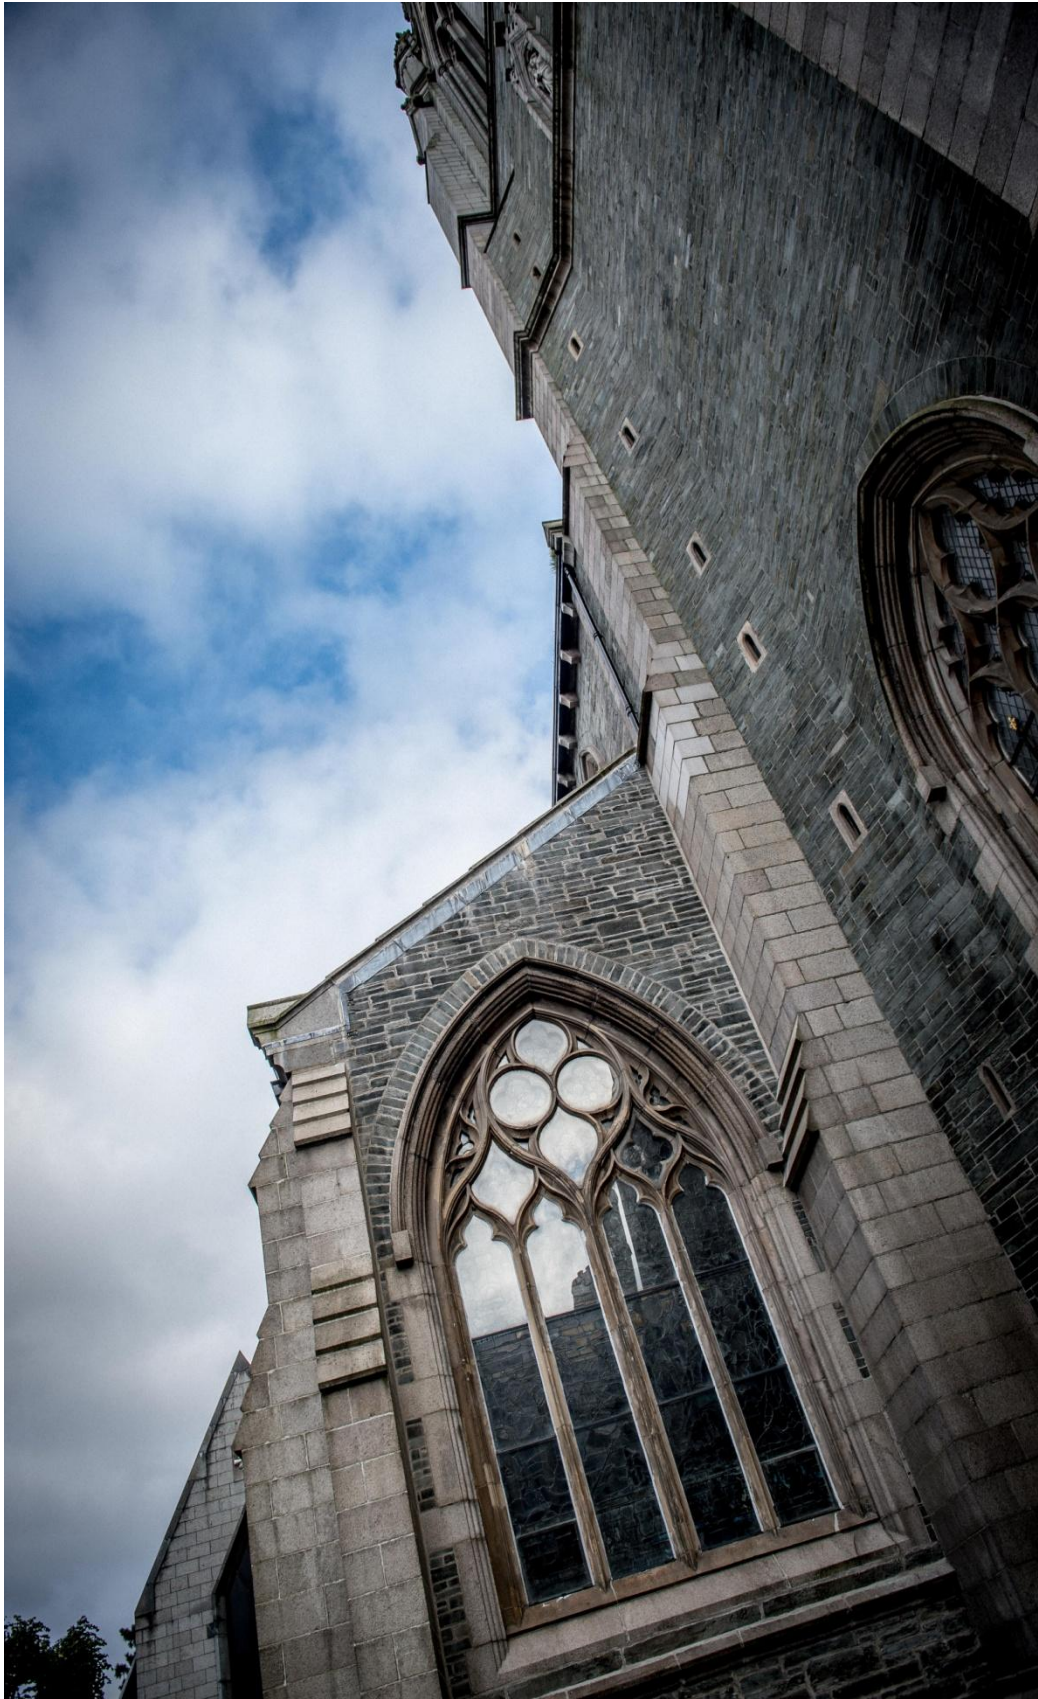
North Side of Bell Tower and St Columba Window

The areas of wall surrounding the window to the Great Western Porch had areas of open joints and significant cracks. All have been repointed using lime mortar.

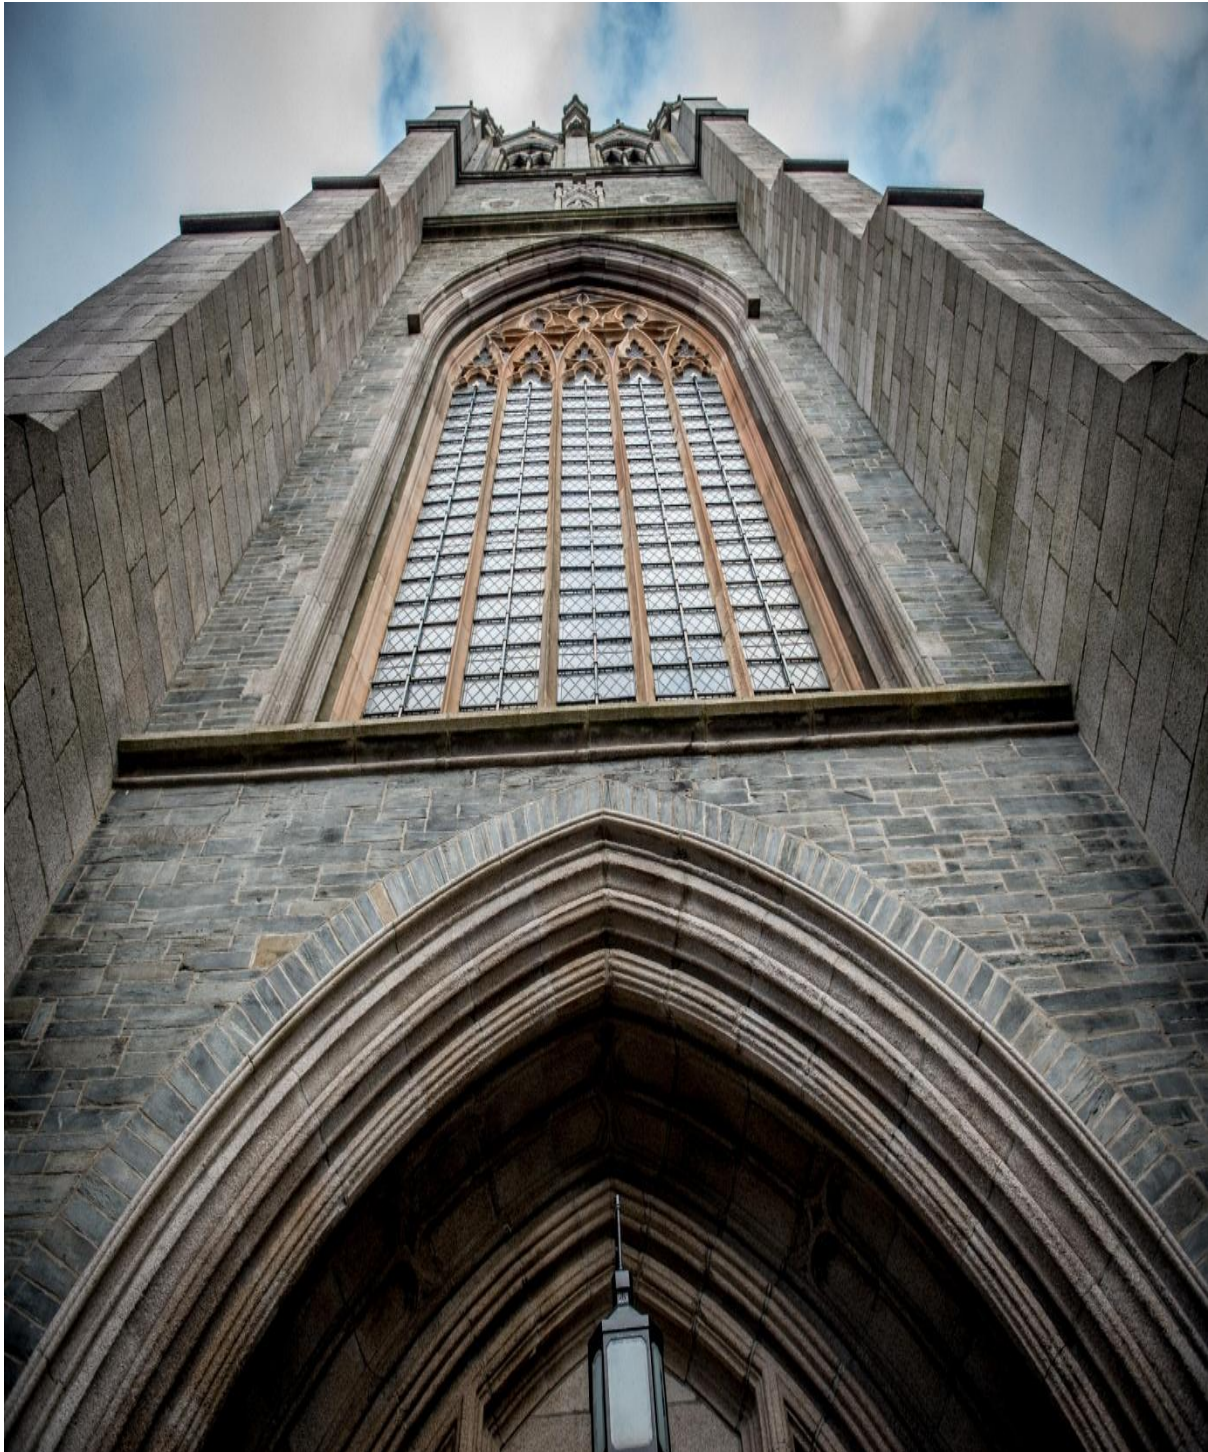
Bell Tower & Great Western Porch

Open joints and cracks were contributing to penetrating damp. The entire wall from the statue of St Eugene down to the ground was raked out and repointed. The existing lantern was refurbished.

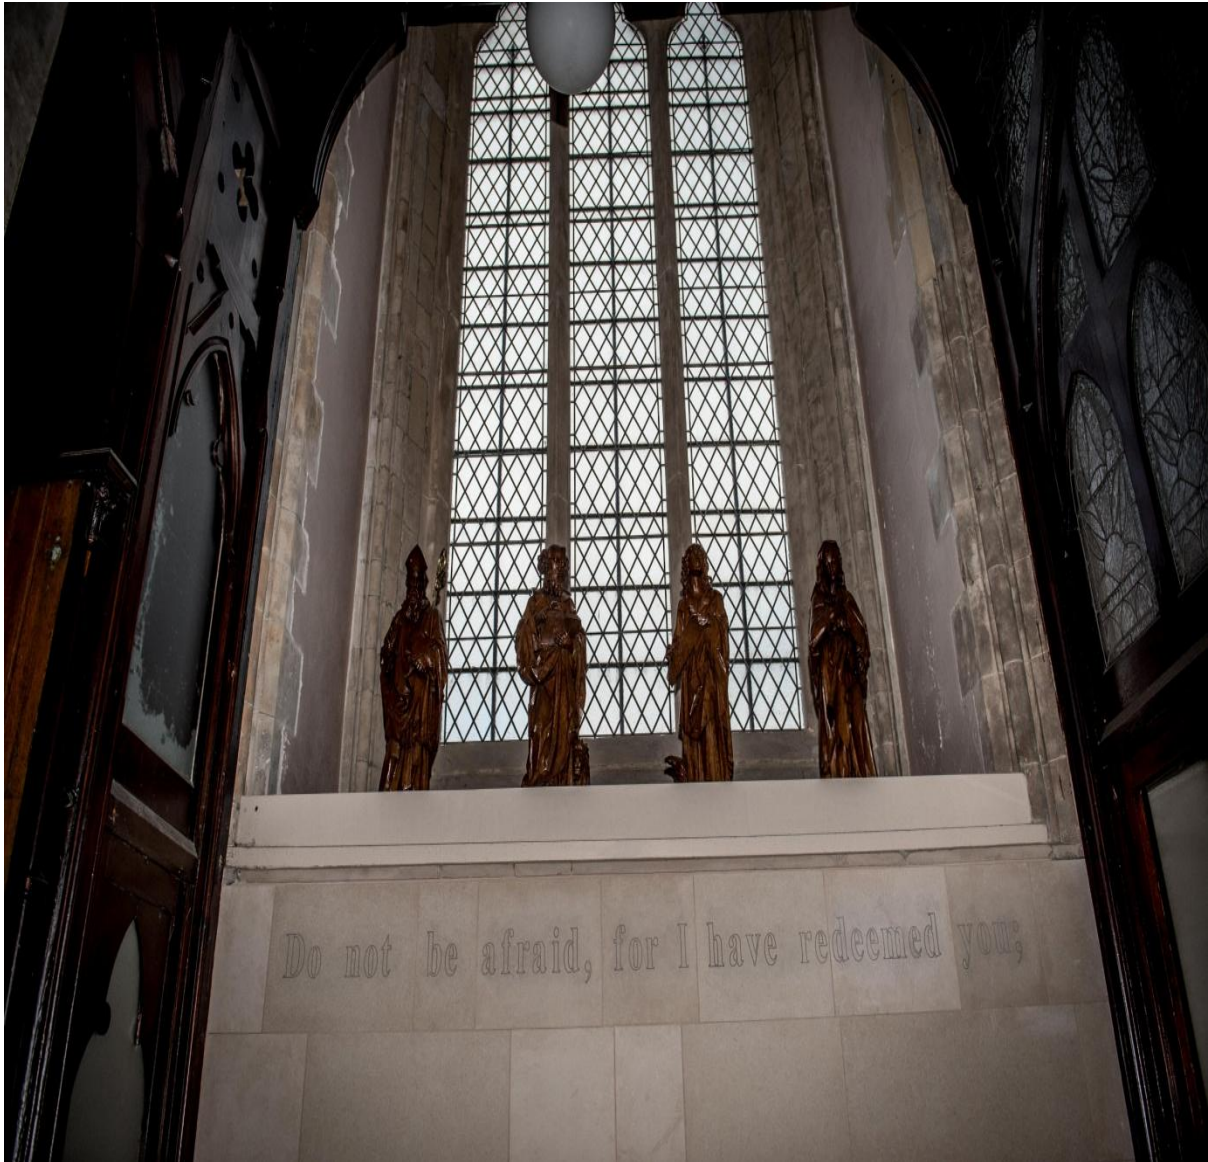
Great Western Porch

This is the main ceremonial entrance to St Eugene's Cathedral, and had become quite run-down. Stonework had been painted over to conceal large areas of damaged tracery, quoins and reveals. Damp entry points were dealt with from the outside, and paint was completely removed and new 'indents' of sandstone inserted. Lower walls were lined with sandstone tiles and a new setting created for the precious Austrian oak statues which had originally been part of the pulpit canopy removed in the 1980's.

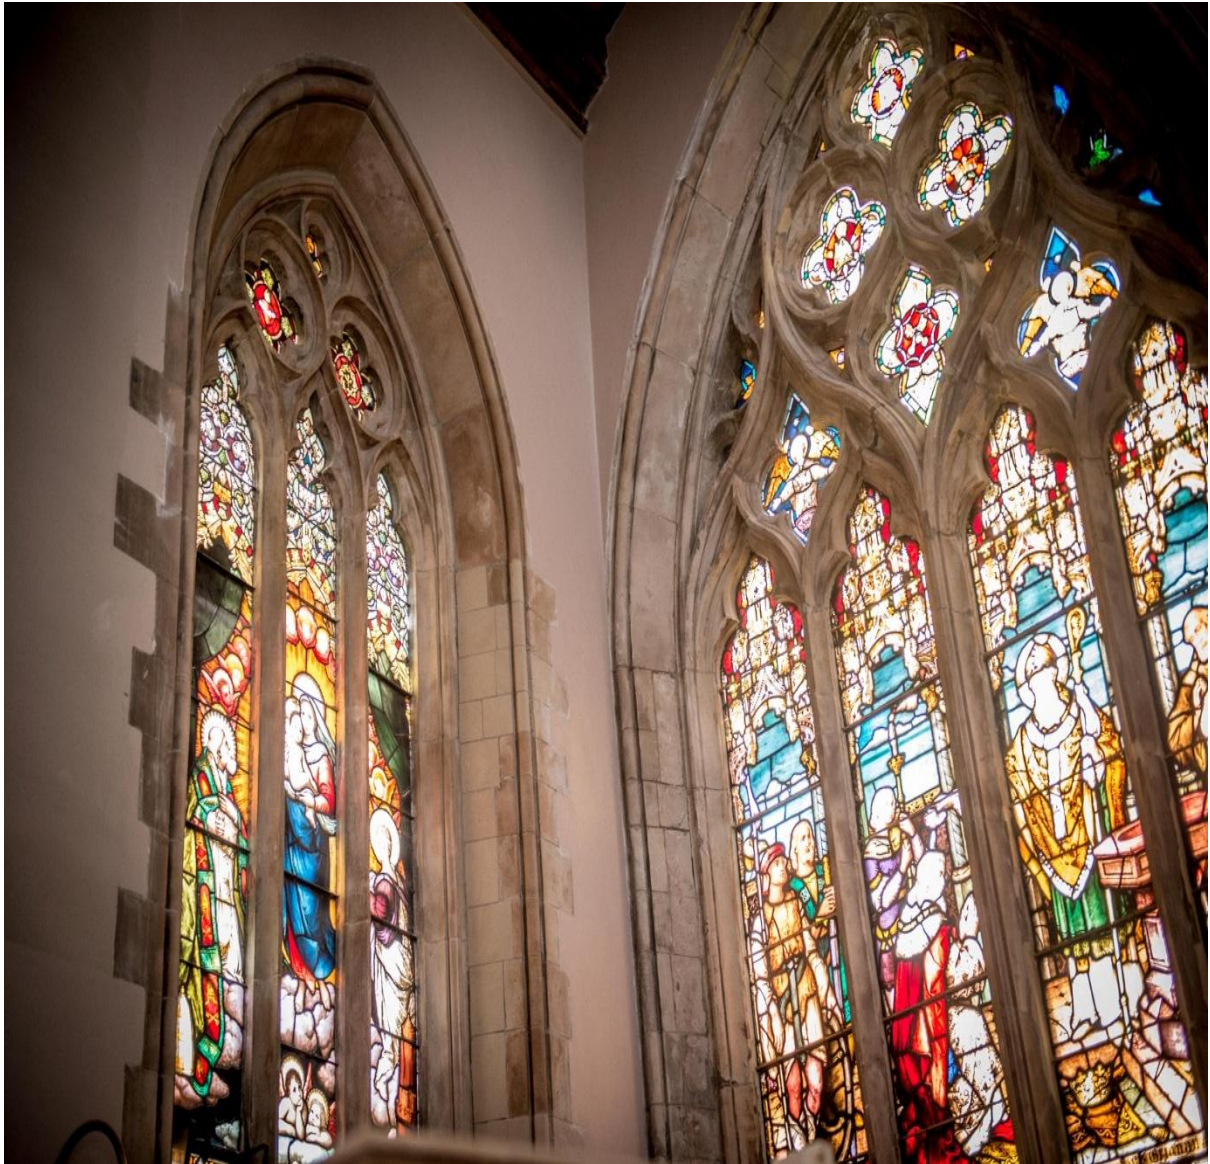
St Patrick's and Sistine Madonna Windows (Interior)

These windows are located on the most exposed corner of the building and have probably suffered from damp since the Cathedral was built. Major damage had been covered up with an epoxy cement and many parts of the tracery were barely holding in the stained glass. We carried out substantial and lengthy stonework repairs. This involved completely removing the stained glass from St. Patrick's window, allowing new stone mullions and tracery elements to be repaired. The glass was refurbished/ repaired and protected with new (ventilated) storm glazing. A substantial area of boast plaster was removed and replaced with layers of lime plaster.

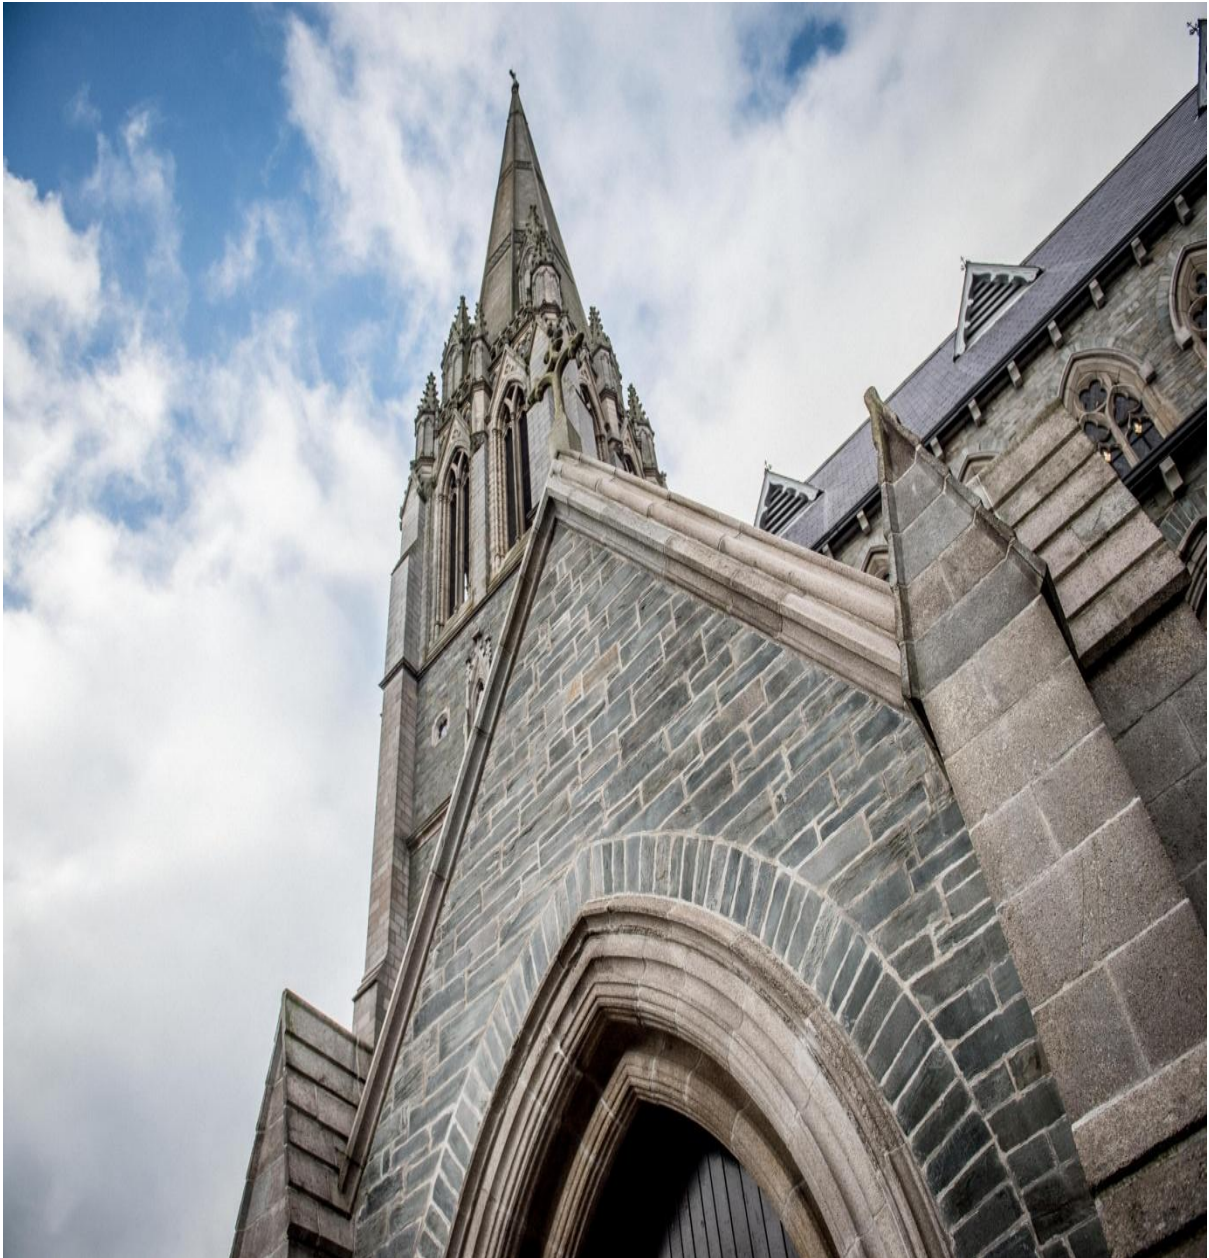
South Porch

Open joints and cracks contributed to substantial damp within this porch. The entirety was repointed and cleaned.

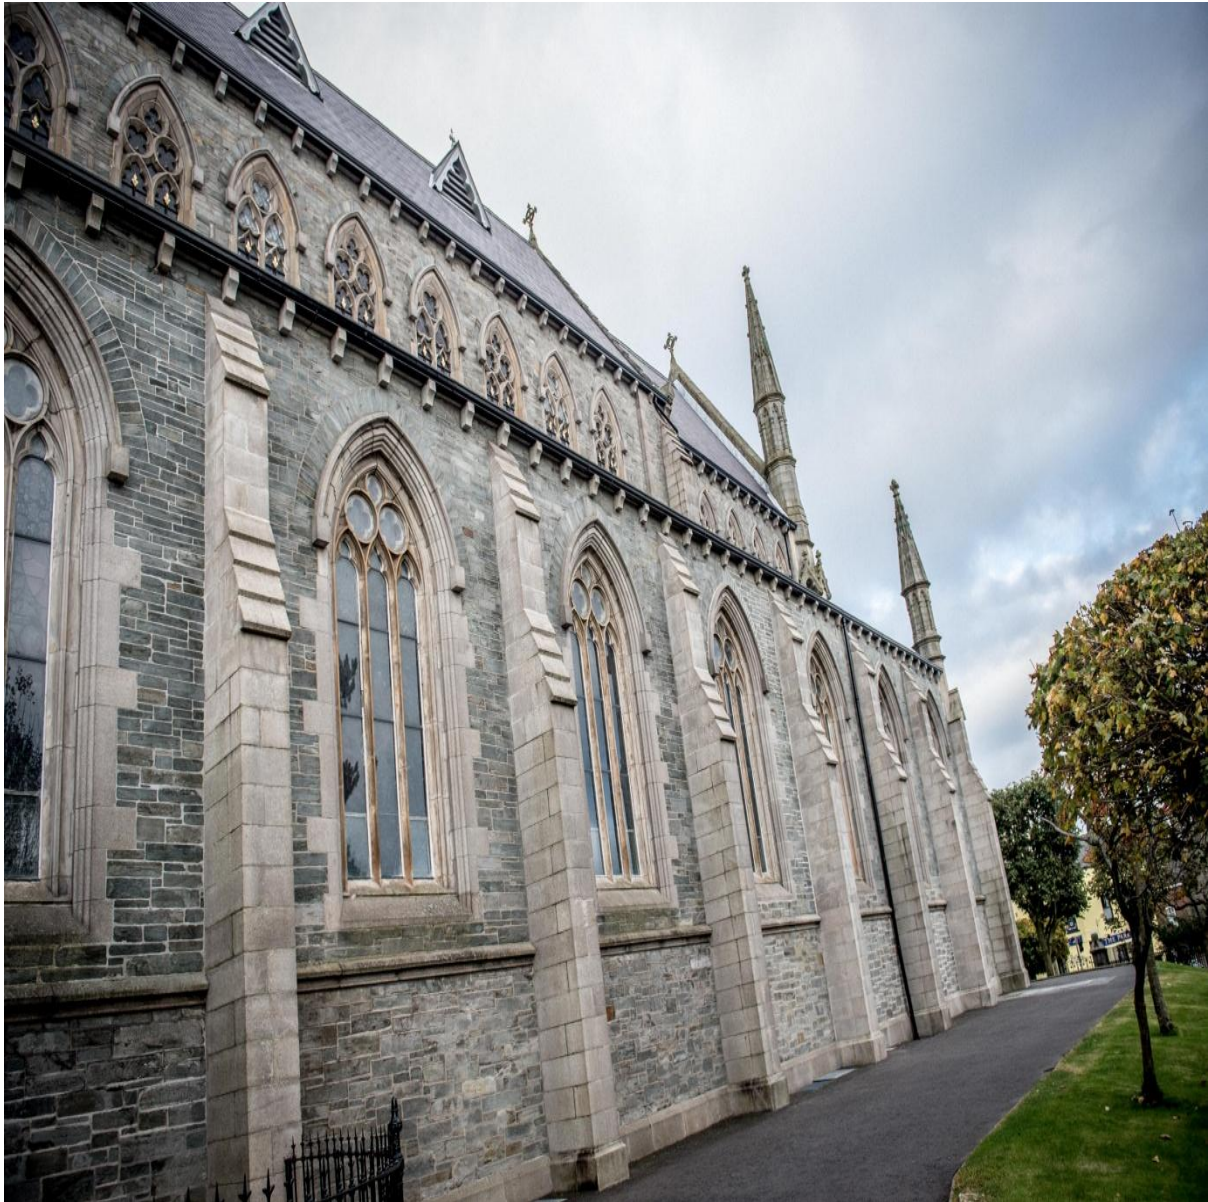
South Aisle Exterior Wall

This is an exposed area of the Cathedral. The granite buttresses and wall panels had a lot of open joints and cracks. Large areas were repointed and cleaned.

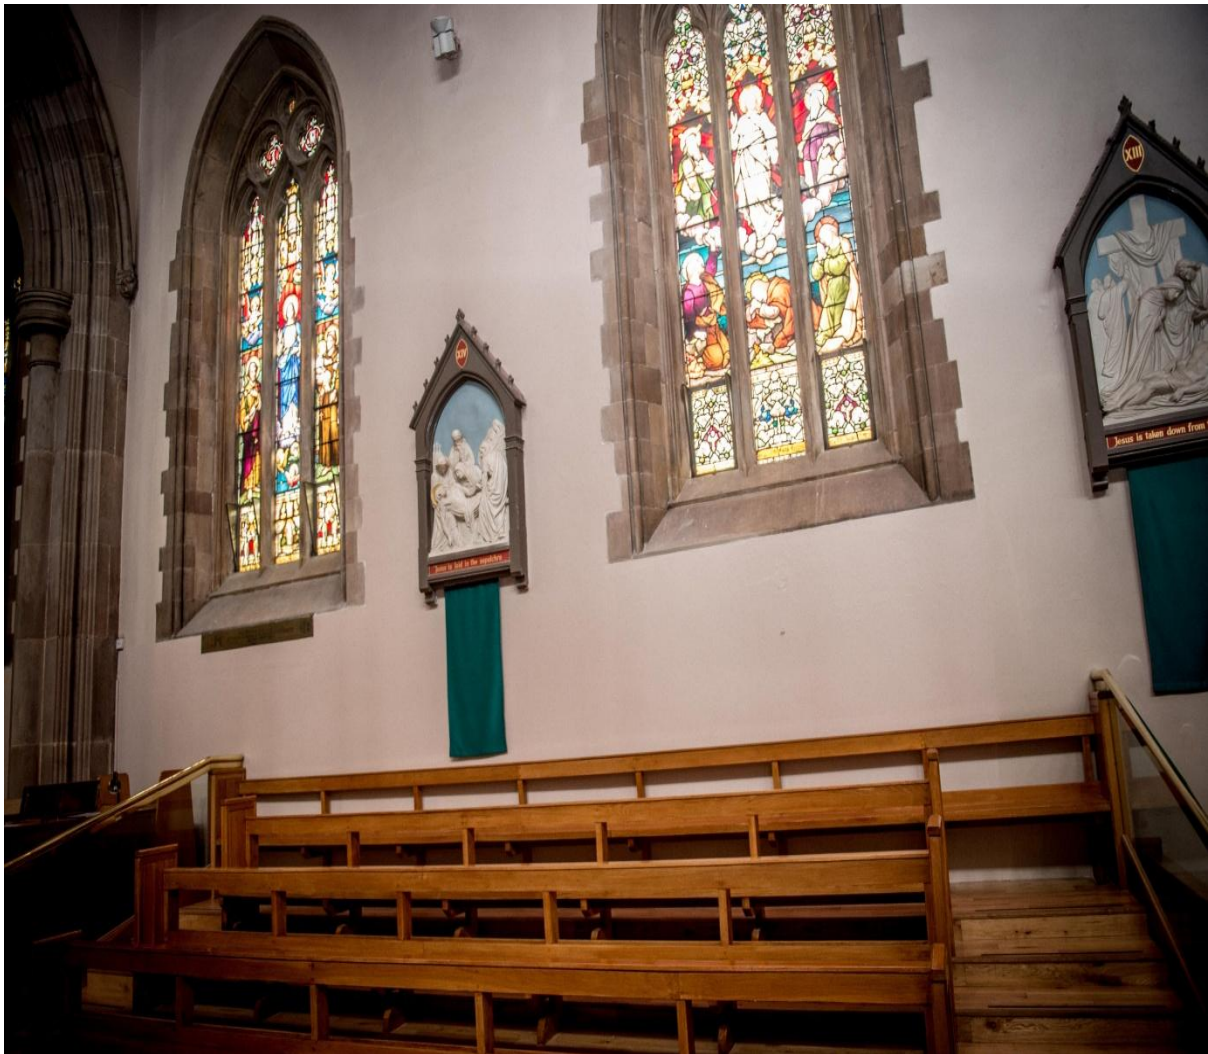
South Aisle Interior Wall

Boasting plasterwork resulting from damp was threatening to fall on members of the Choir. This was stripped out and replaced with layers of lime plaster which will allow the wall to breathe as originally intended.

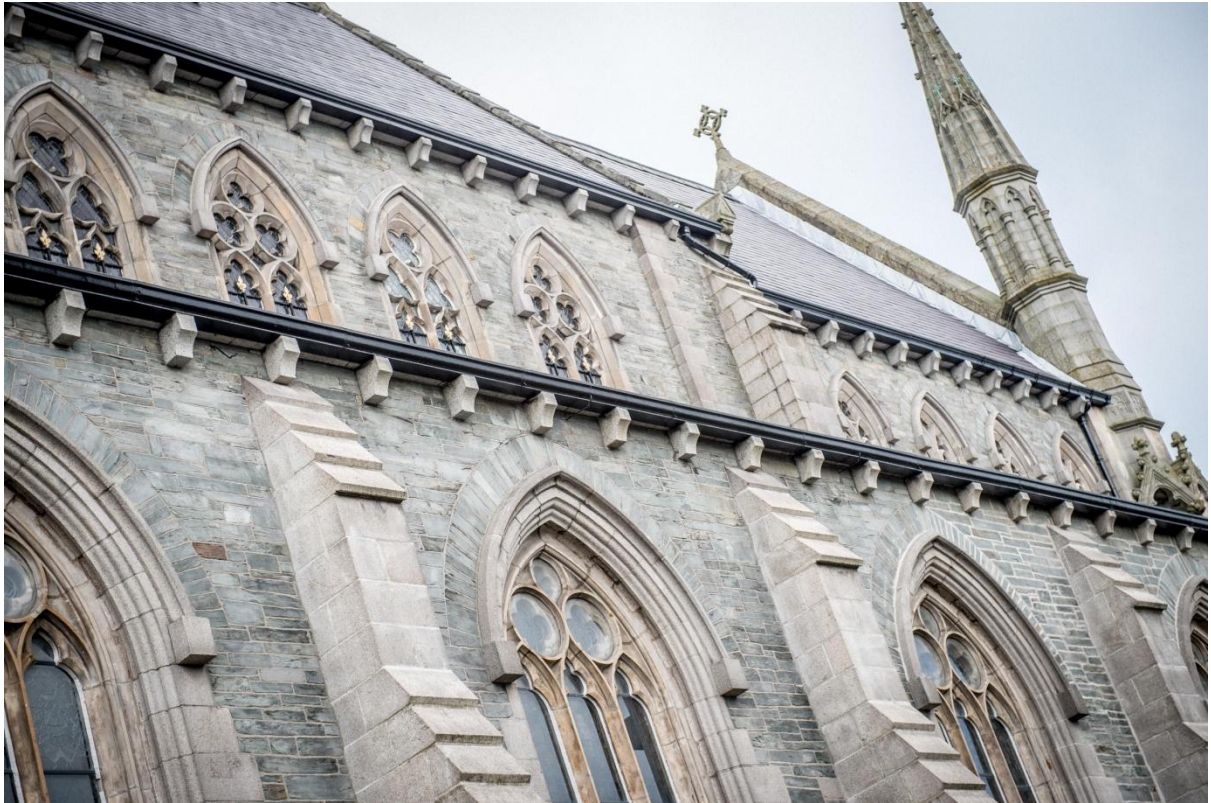
Rainwater goods

All cast iron gutters and downpipes required maintenance and minor repairs. Joints were sealed, a number of sections replaced (using a custom mould) and all rainwater goods were painted.

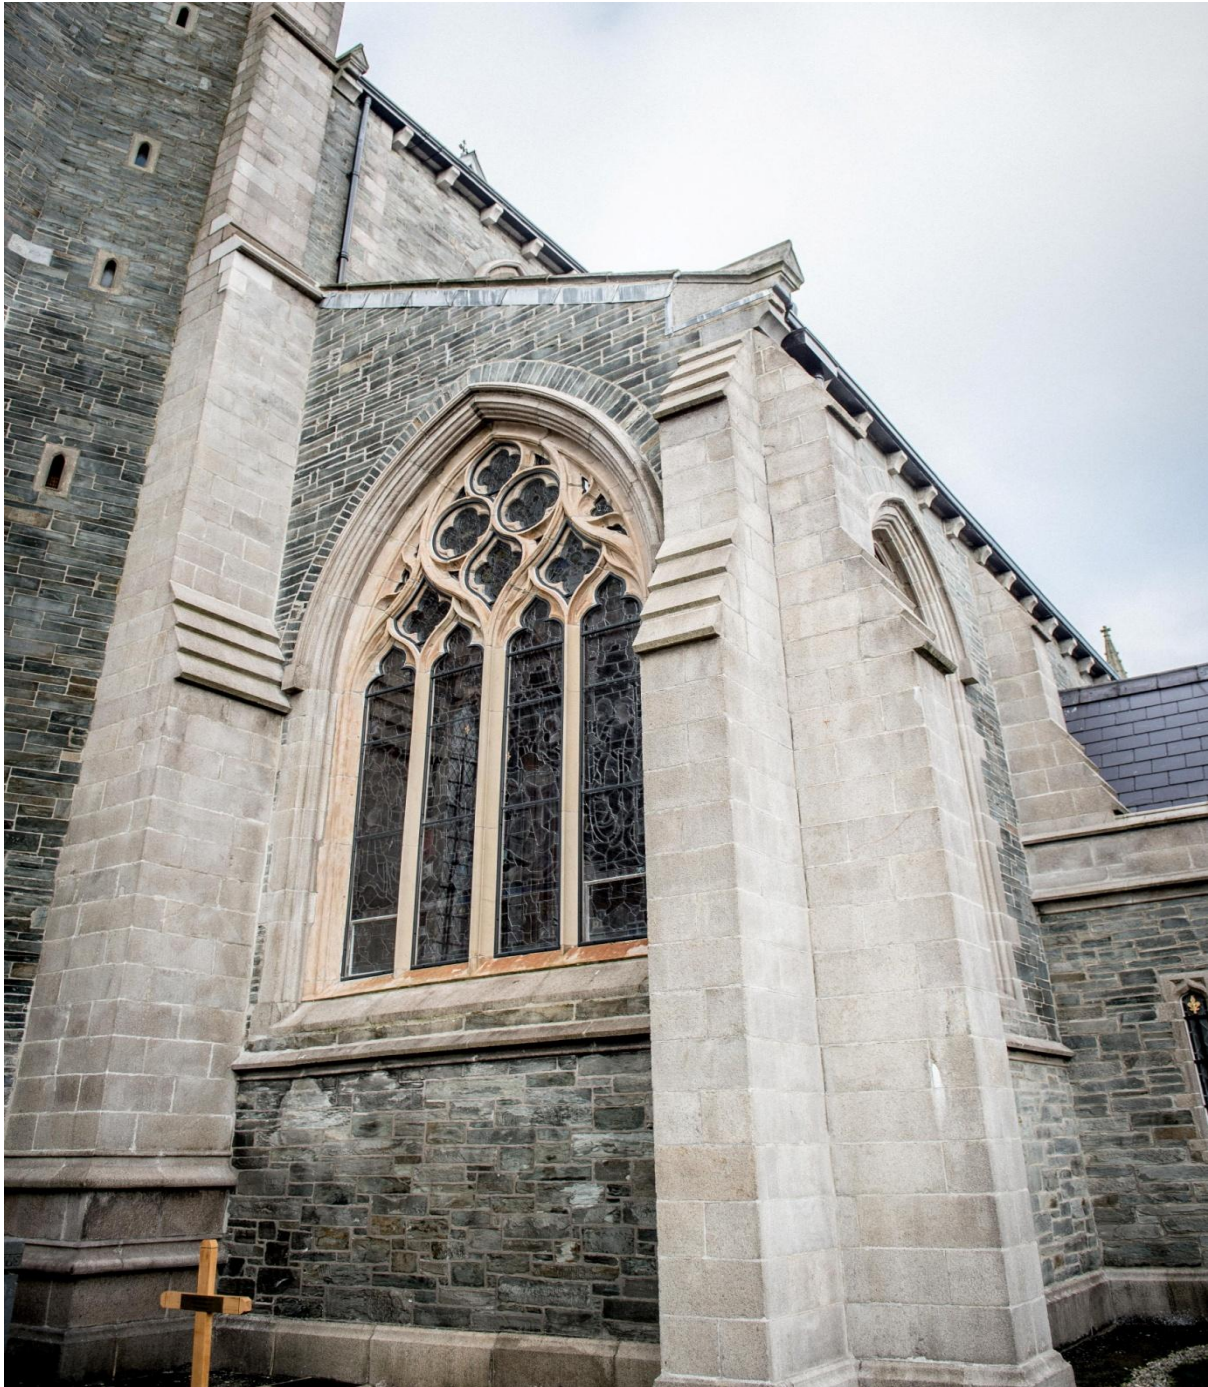
St Patrick's Window (Exterior)

This window was in a very poor condition as a result of damp and unventilated storm glazing. A large number of stone 'indents' were required to the tracery, mullions and reveals. the storm glazing was replaced with a ventilated system. Damp was also entering at ground level as the area was waterlogged, this has been drained with immediate result.

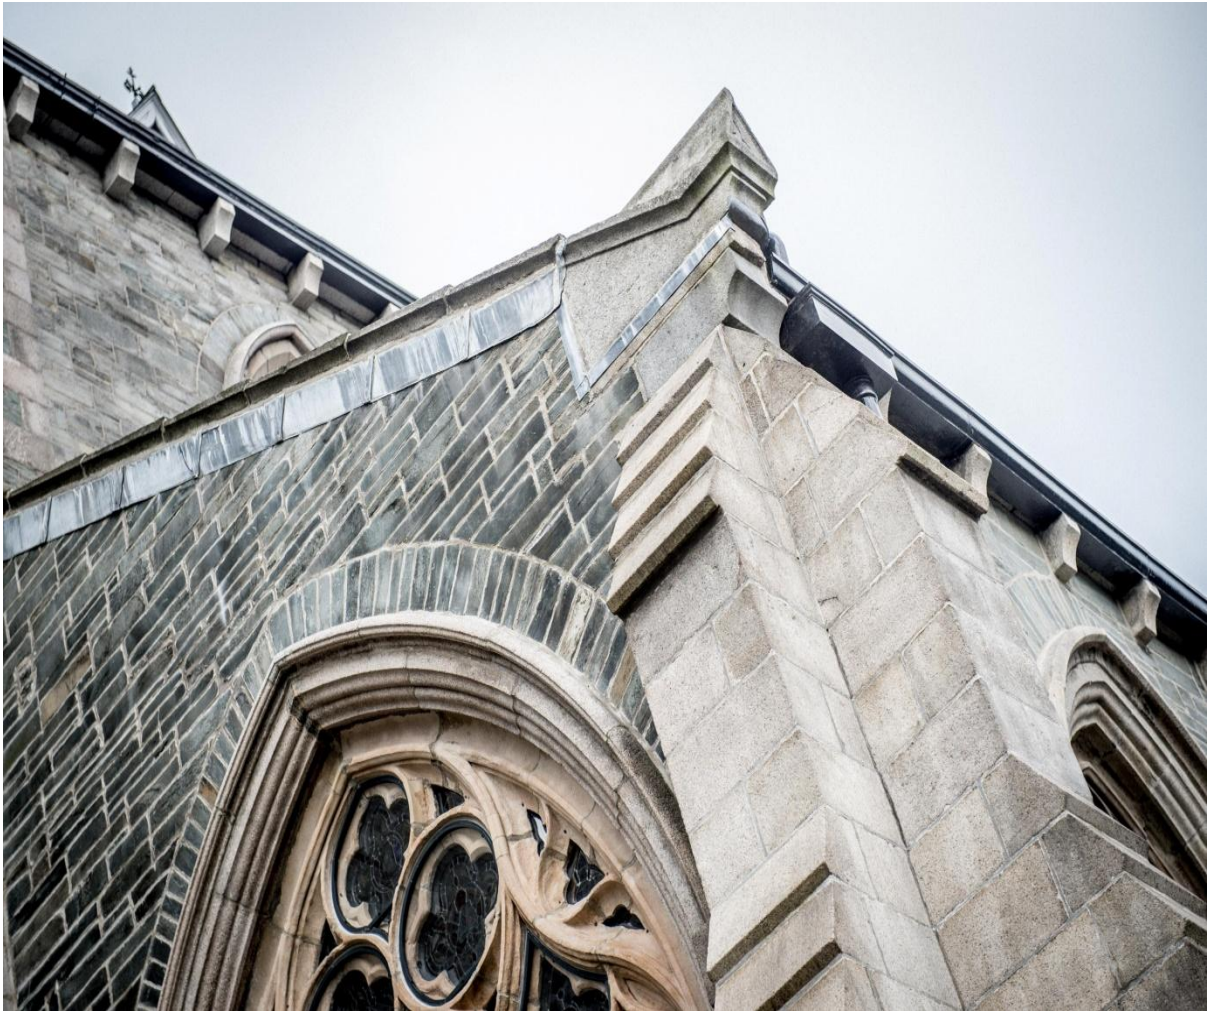
St Patrick's Window (Detail)

Damp was entering these walls from the parapet, a cracked downpipe, damaged buttresses and generally from open mortar joints and cracks. Rainwater ran down the parapets to the back of the stone kneeler, whereupon it entered the corner of the building and into the reveal of the window (a process known as 'tabling'). The copings and kneeler were lifted and new leadwork inserted. All mortar joints (cement) were raked out and repointed using a breathable lime mortar.

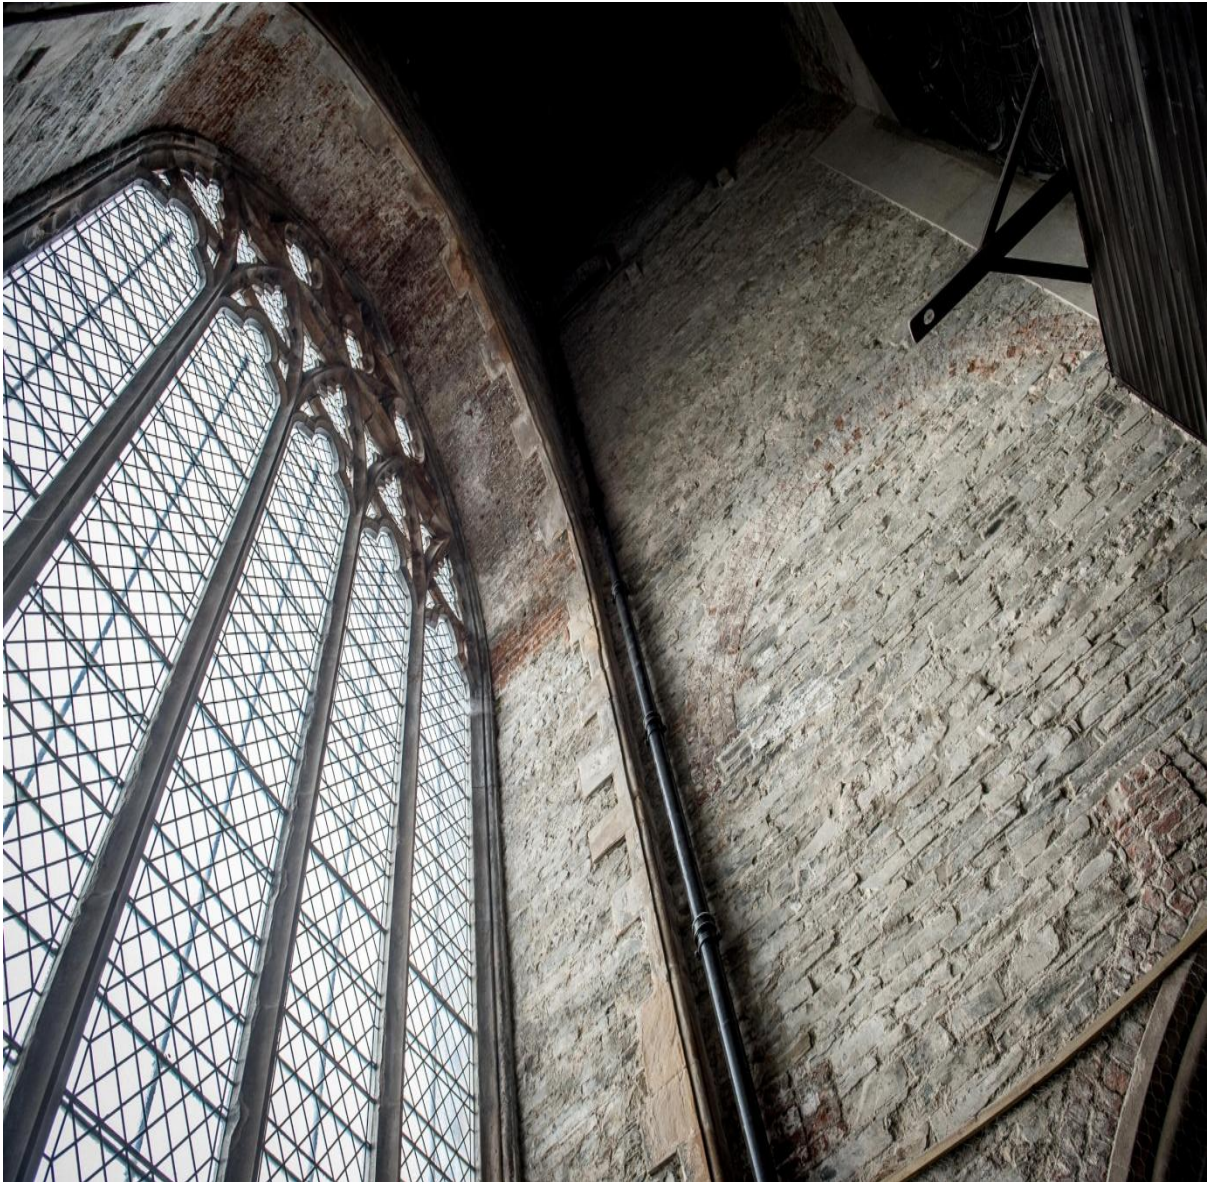
Bell Tower Interior

Large areas of these walls were suffering damage as a result of damp. The entire tower interior had been covered in a cement render, which was trapping damp inside the walls. This layer was completely removed, the walls repaired as necessary, and the structure can now breathe as originally intended.

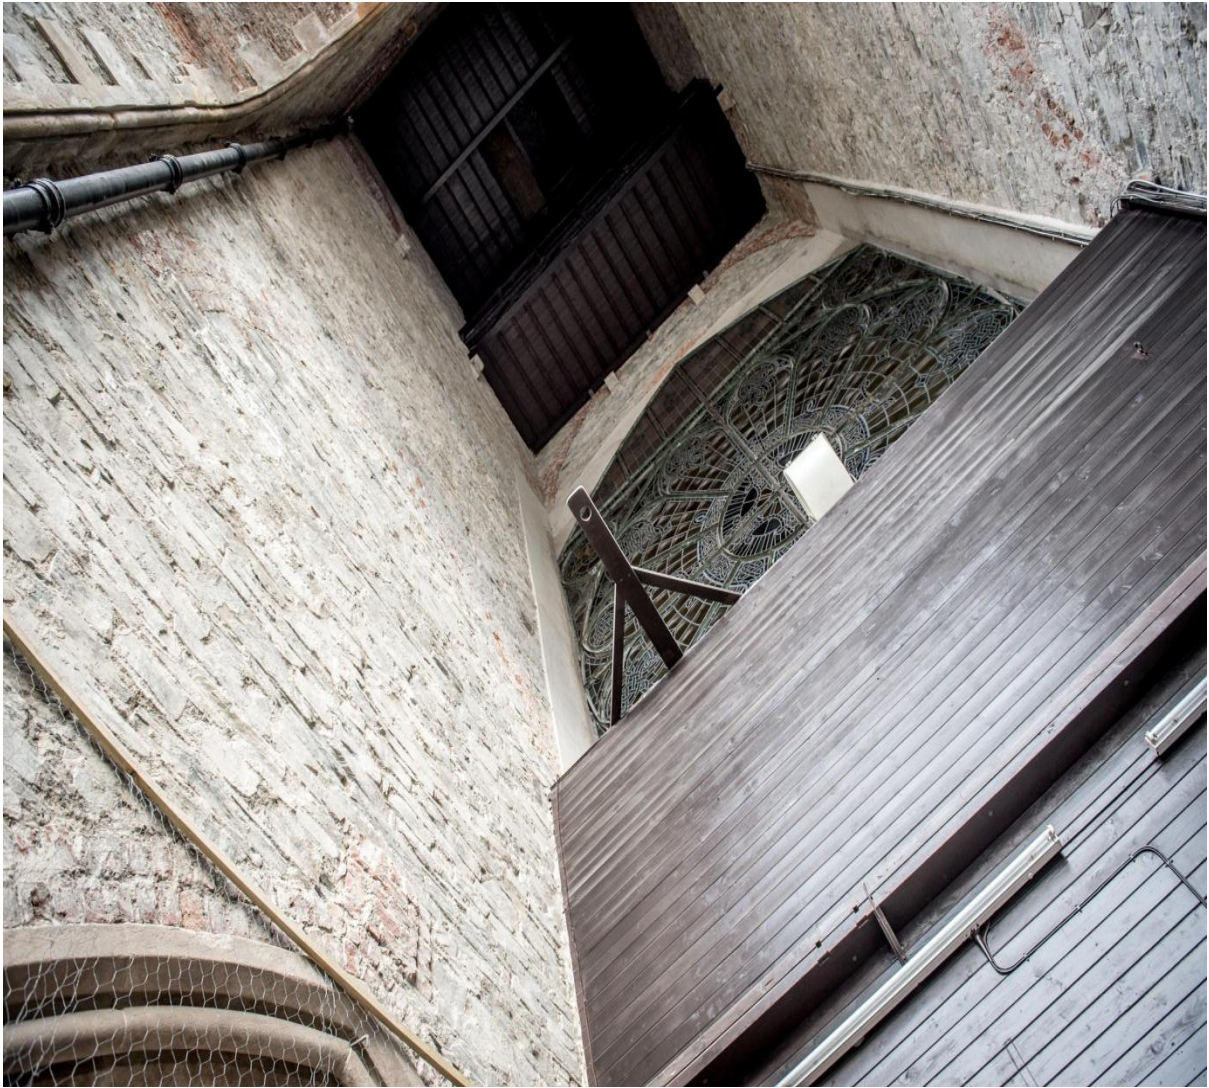
Bell Tower Interior

This space also suffered from poor ventilation, trapping humid air and inhibiting evaporation of damp. We added ventilation to the top to create a stack-effect where fresh air is pulled in from the porch below and exits via the belfry, carrying moisture with it. You can see an original bell-pull eye in the middle of this picture.

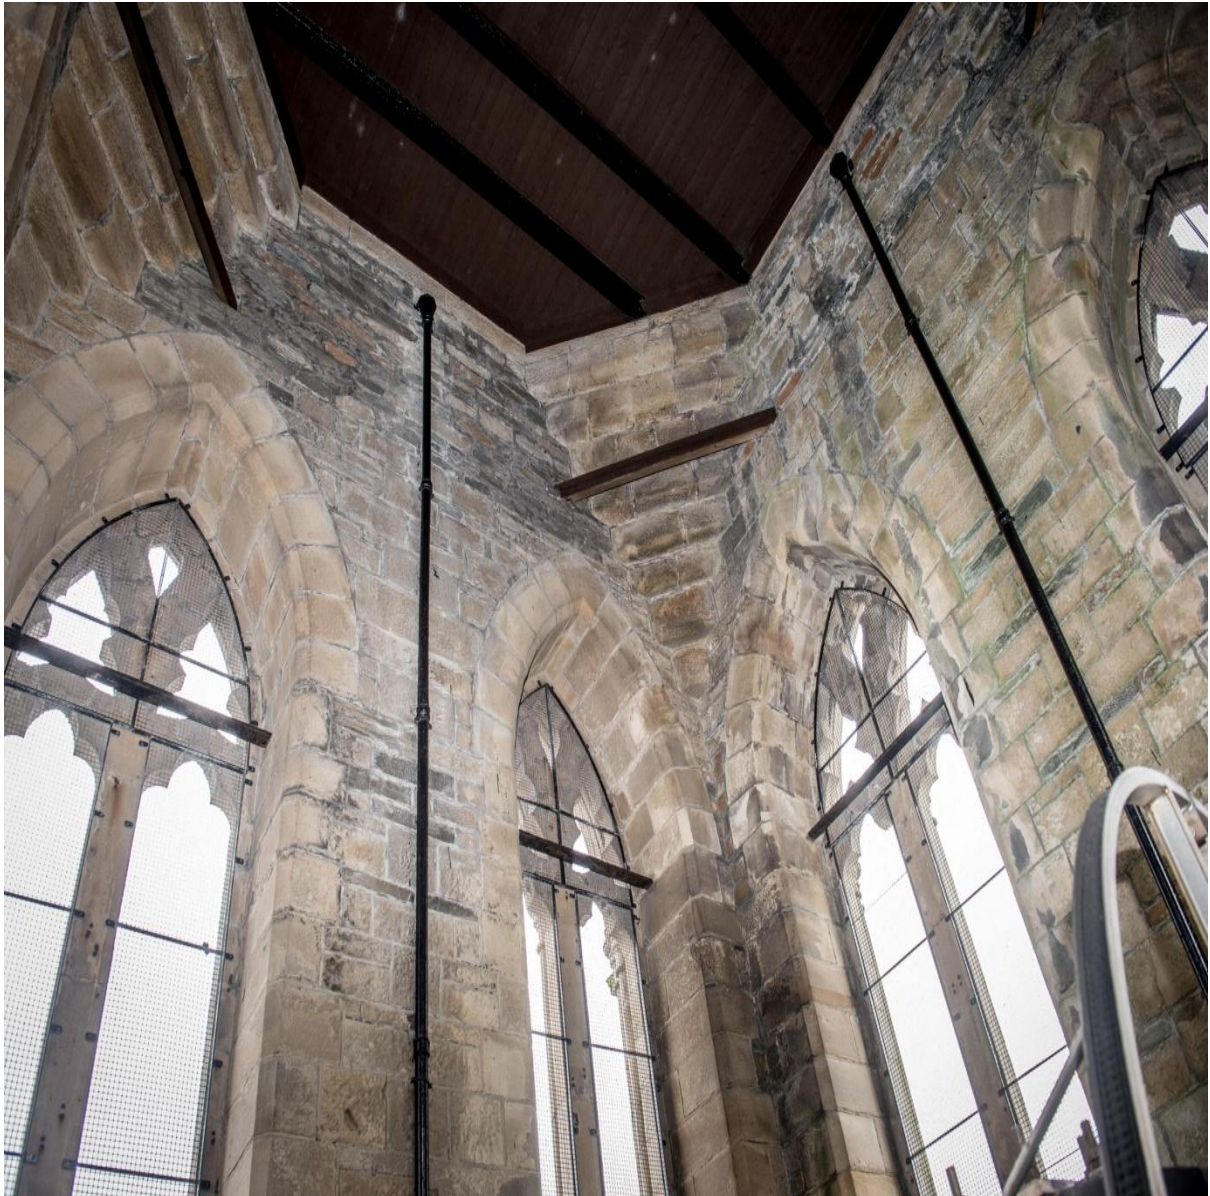
Belfry

The North and West walls were completely saturated, with water travelling downwards through the bell tower. The outlets on the spire parapet gutter were poorly detailed, and constantly blocked. New outlets were inserted, and the stone gutter sealed. The cast iron access ladder to the spire roof space was in a dangerous condition and was replaced with new galvanised ladders incorporating a fall arrest system.
