Completion of essential repairs and refurbishment at St Eugene's Cathedral

The aim of this project was to carry out essential repairs and maintenance primarily associated with damage caused by the entrance of moisture to the fabric of the building.

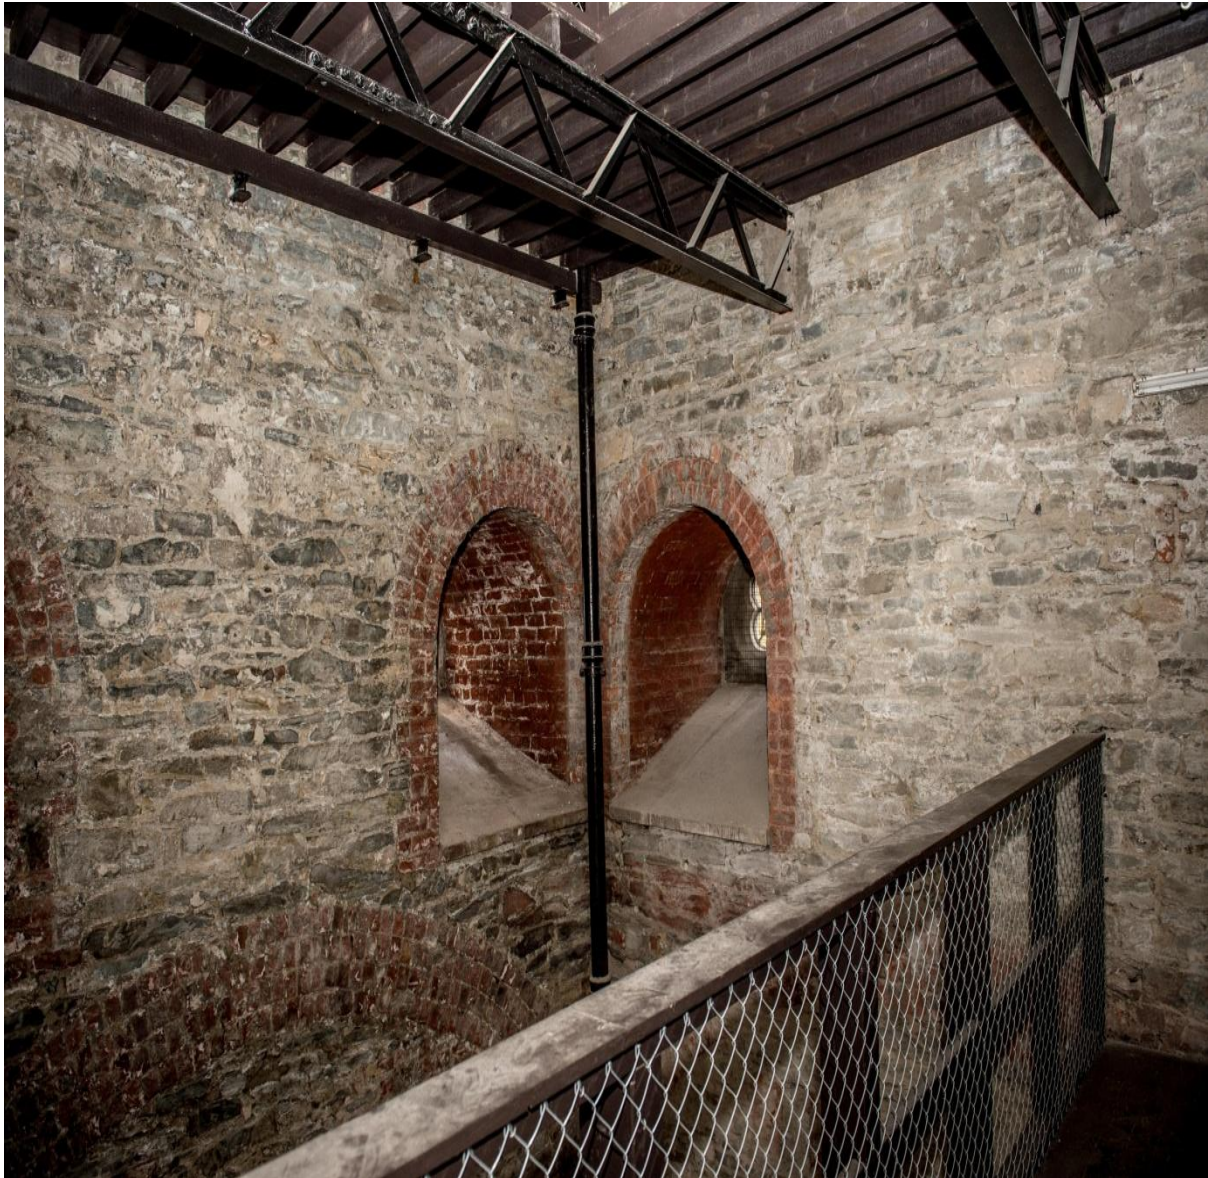
Half Platform Level, Bell Tower (two levels below Belfry)

Walls were stripped of the cement render to allow the structure to breathe. Ventilation was added to two of the window openings. All wood and iron-work were painted.
