**St. Eugene's Cathedral
Francis Street
Derry**

Condition Survey

July 2012

STONE CONSERVATION SERVICES
CONSARC DESIGN GROUP

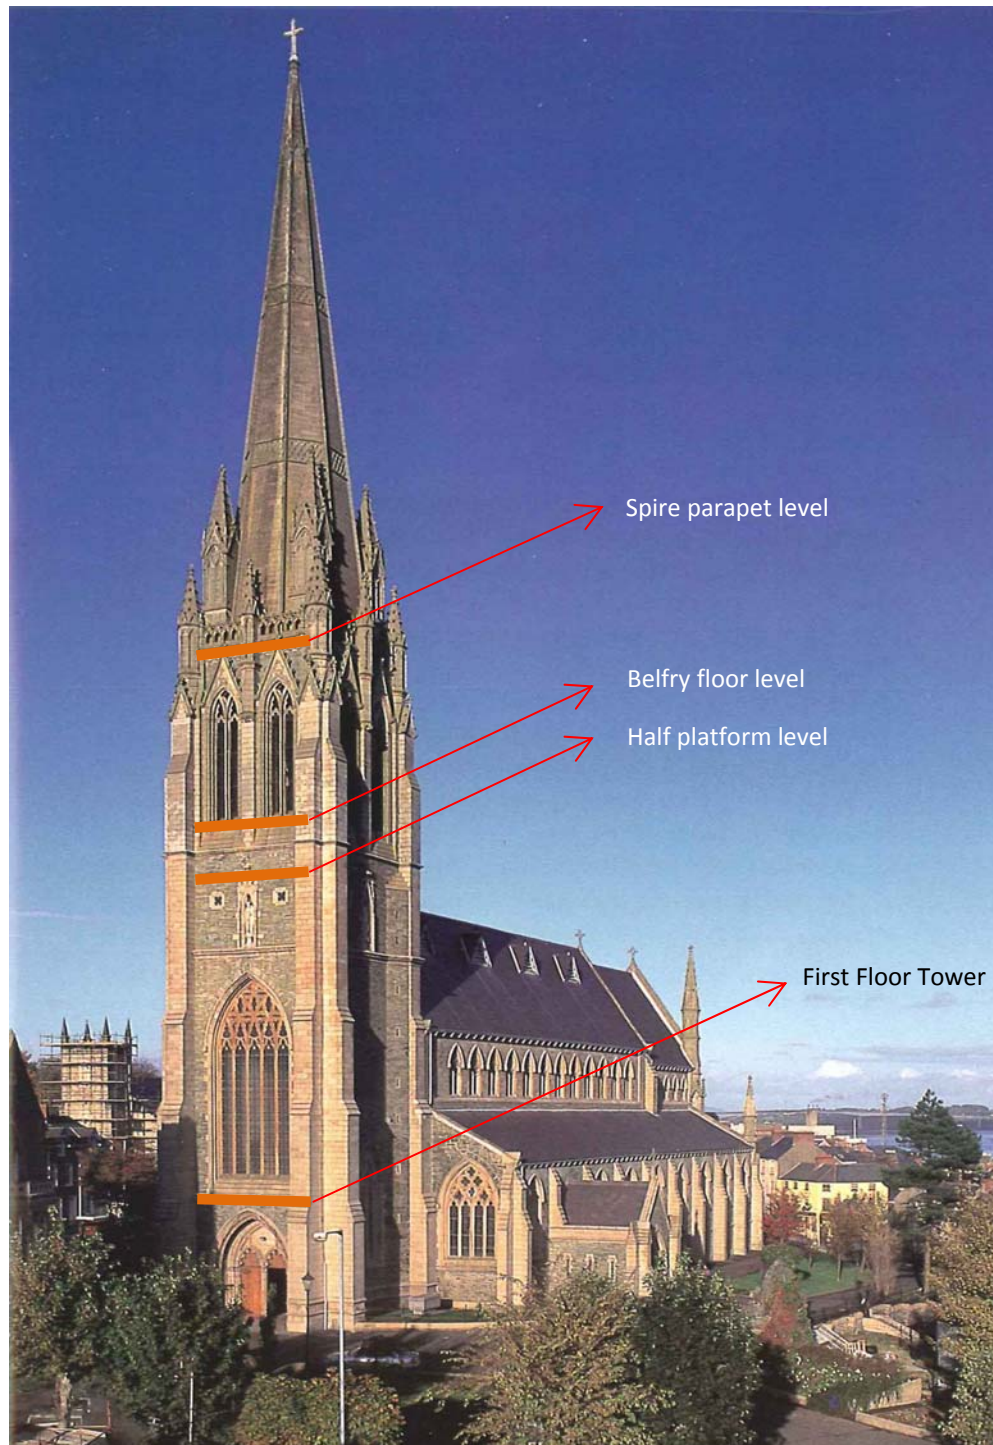
FIGURE 1

2.01 First Floor Level (Refer to Figure 1 and Photographs 1 – 7)

Damp is present in the tower at the level of the large feature tracery window. With such an exposed tower wind driven rain soaks through the Derry Schist and Giffnock Sandstone joints on the tracery window surround. This is a normal cycle and the water that enters into the wall should evaporate back to the external face over time.

However, given the internal environment of the tower is warmer than the outside and having the tracery window on the prevailing windward direction side and with a mass of wall removed to allow installation of the window, means that water from the outside has a short distance to travel to the inner face.

At some stage in the past 25 years this part of the tower has been rendered with a cement based render. This not only traps moisture within the wall but the Gypsum in the cement based renders creates salts when there is moisture behind. This is visible on the photographs.

It would be prudent to form clear sizeable openings in the floor and ceiling that are within the tower up to the belfry area. These could be designed with upstands and lids to prevent water entering.

As this section of the tower is not visible to the public the cement rendered reveals between the tracery window and the sandstone quoins should be removed which will expose the stone or brickwork. This may require localised pointing to open joints. This should be carried out using NHL 2.5 Hydraulic Lime Mortar.

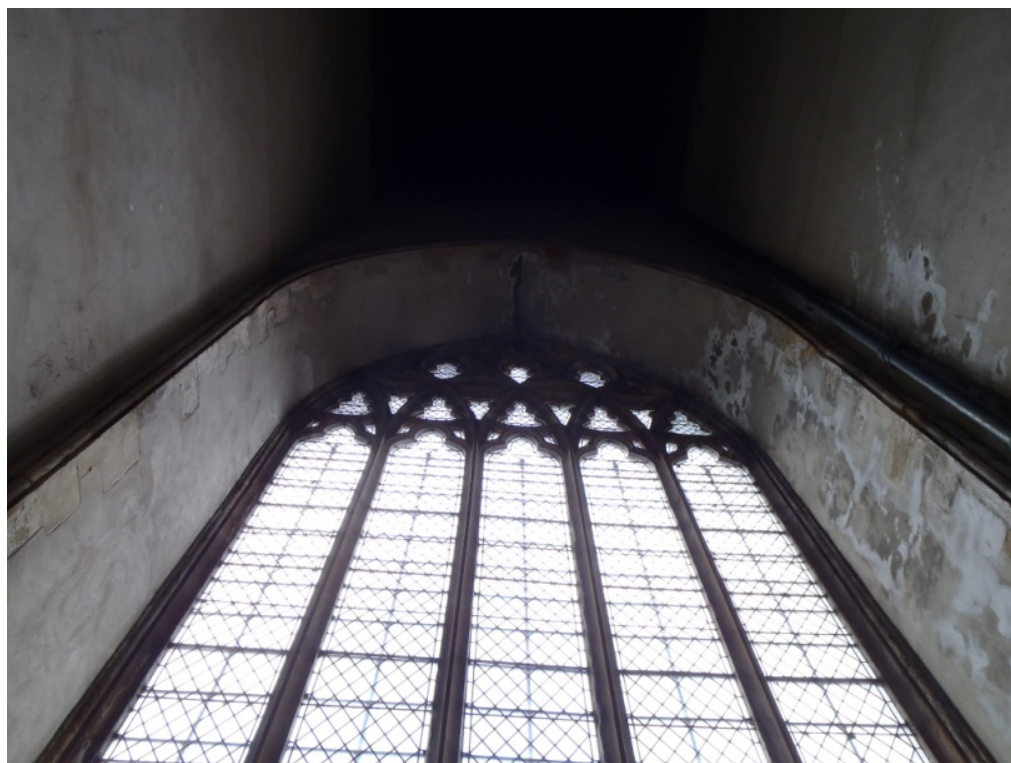
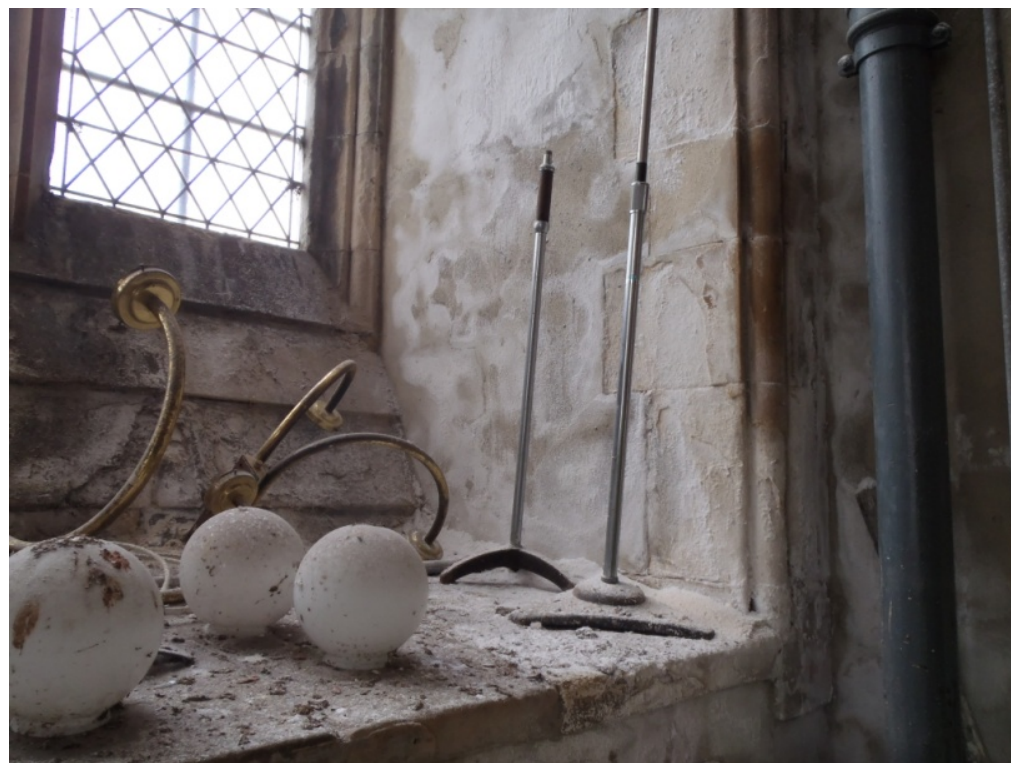
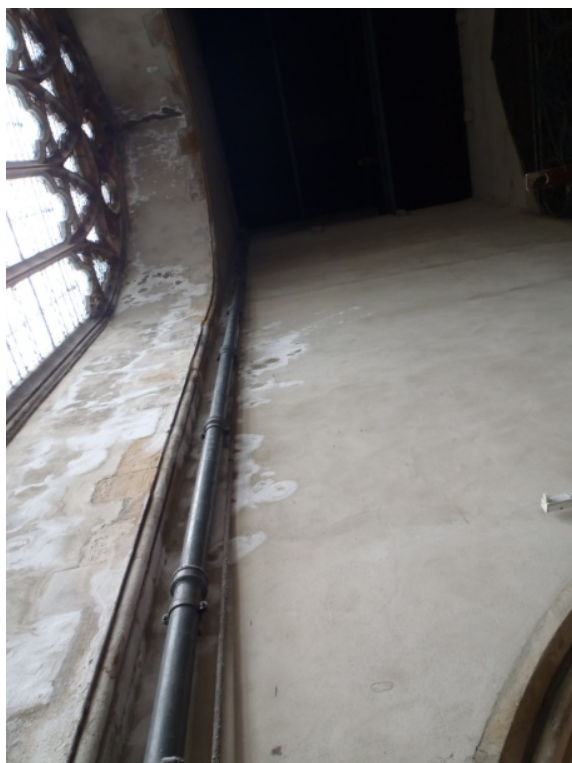
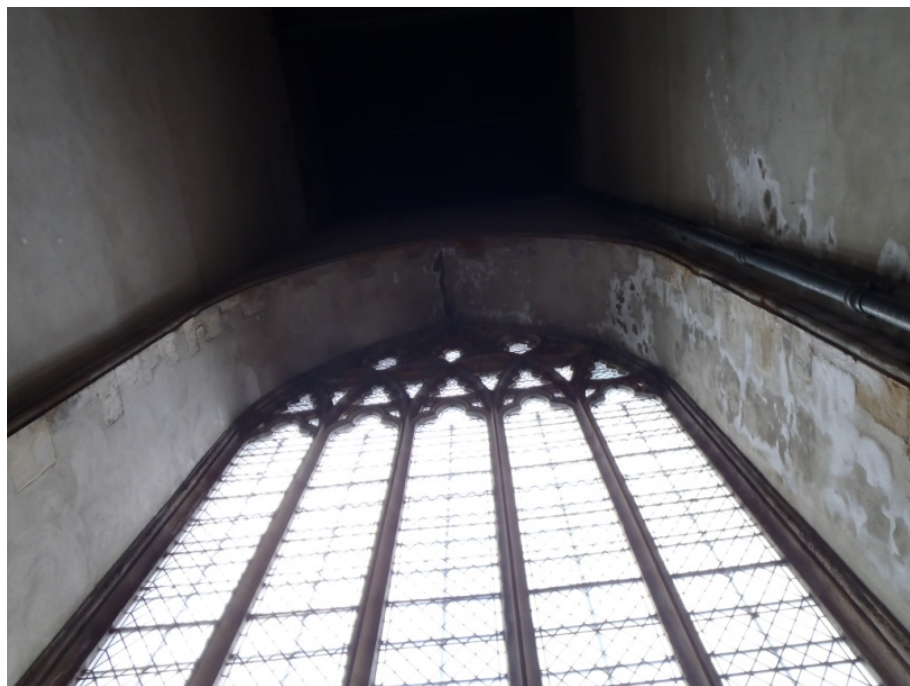
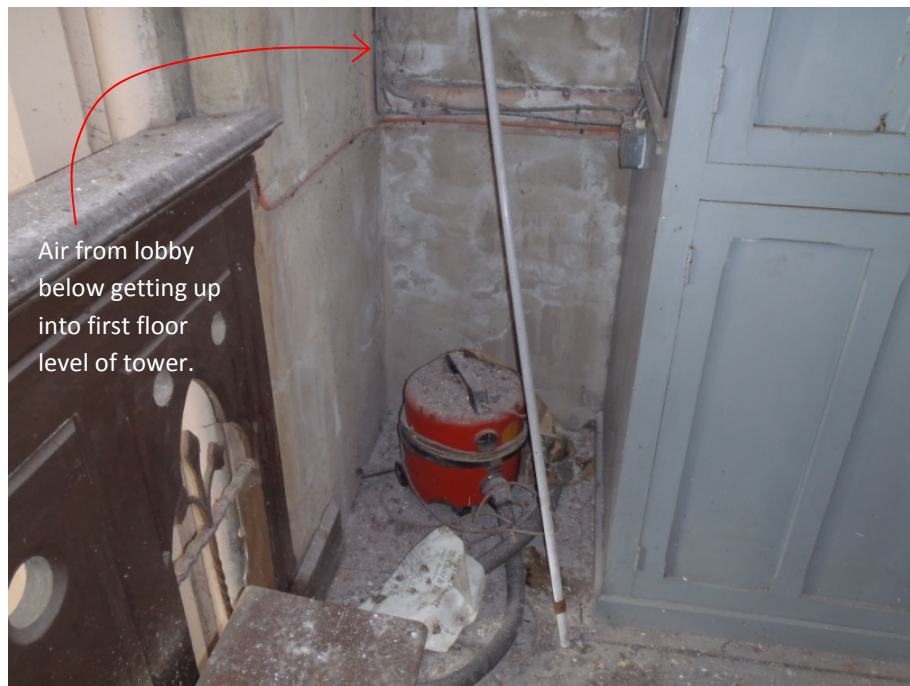
It is important to get air movement within the tower. Once the front door is open, air can come into the lobby and move up past the space at the side windows and ceiling above (Photograph 5). However as there are no window openings or air passage through the above ceiling, the air in this section of tower is stagnant and not permitting the wall to dry quickly.

The stack effect air movement within the tower will eliminate the visible damp to the internal face.

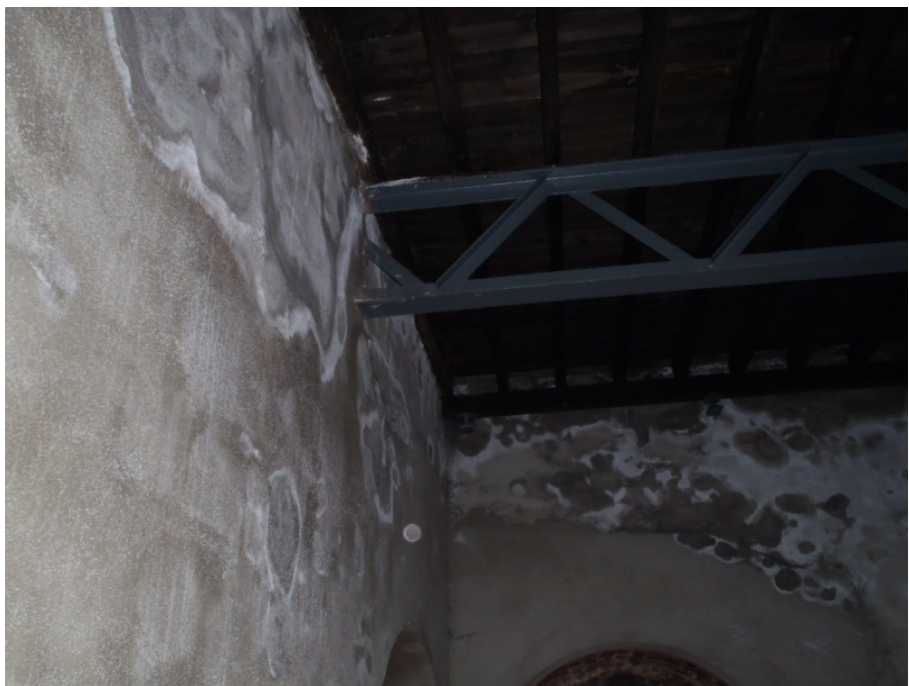
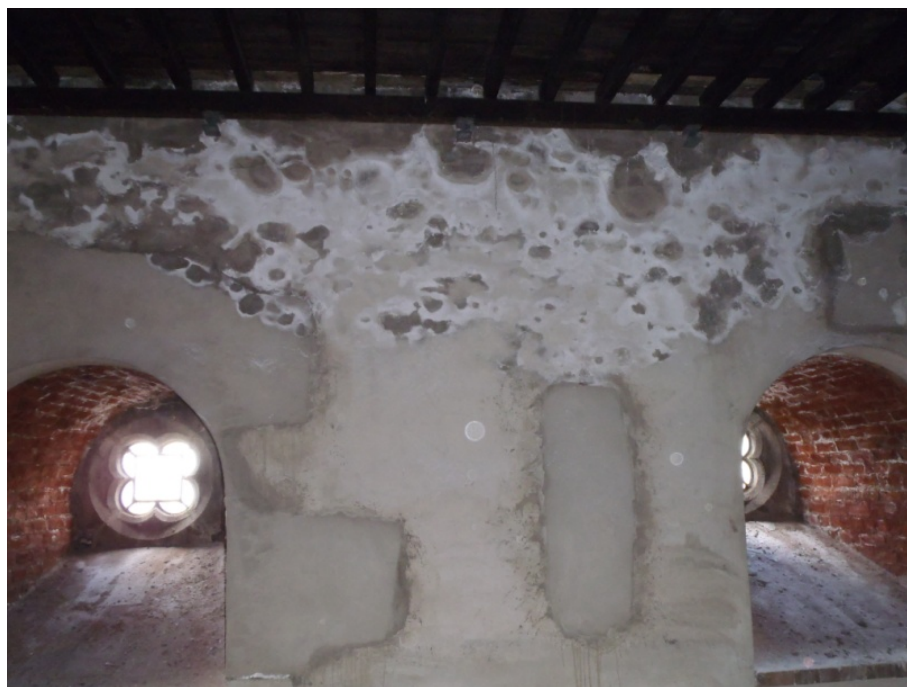
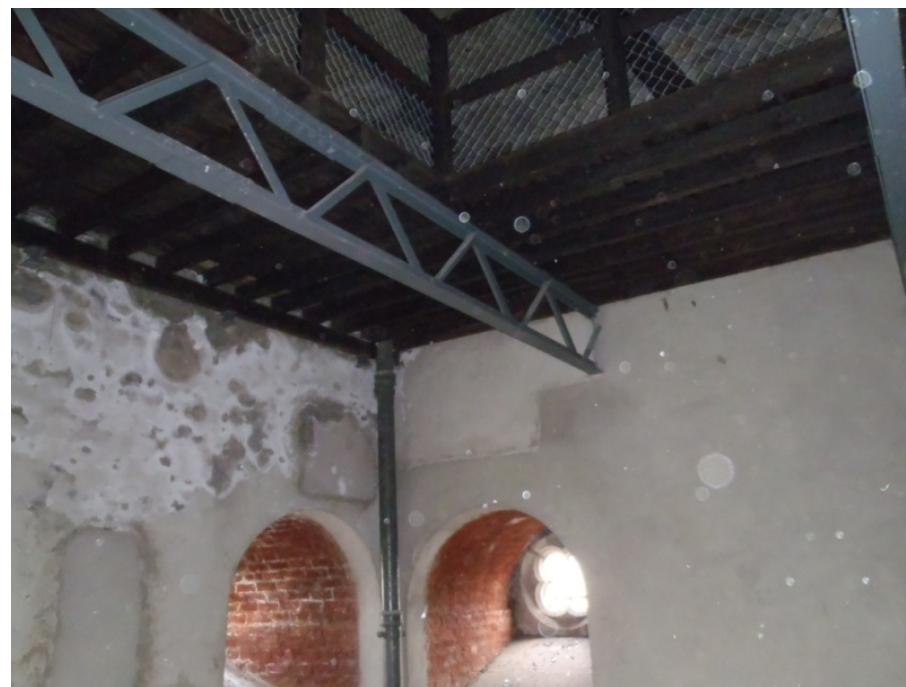
The walls in this section of the tower are covered in a sand cement mix. There is damp and salt efflorescence visible in localised areas (refer to photographs 6 – 8)

The ventilation openings that we are proposing would mean that there is air flow through this section of the tower. This is likely to drastically reduce the current damp and salts on the walls. However, if money was available the cement render could either be removed and the walls left exposed or rendered in NHL 2.5 hydraulic lime mortar.

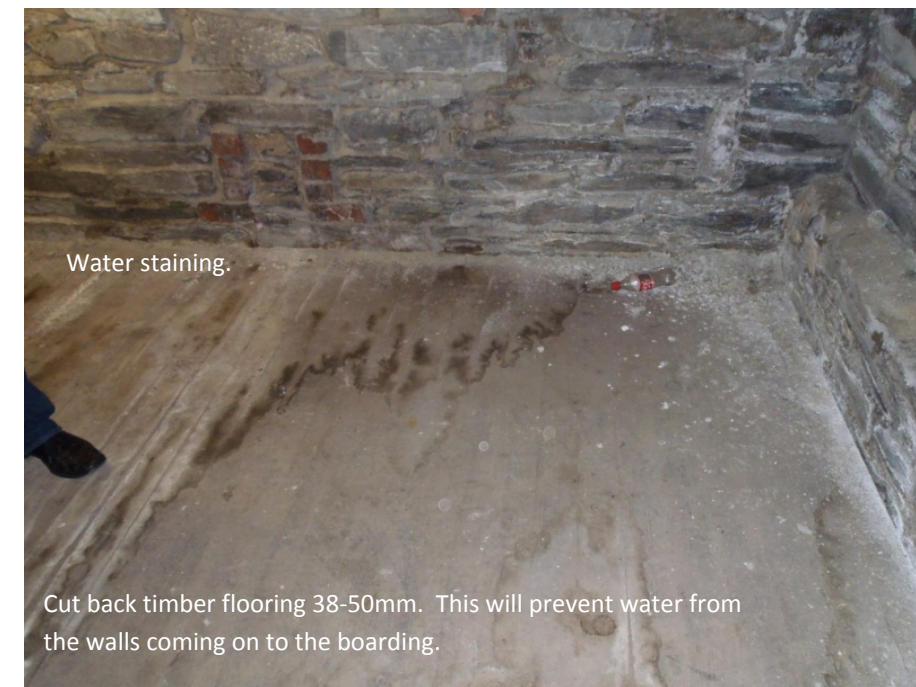
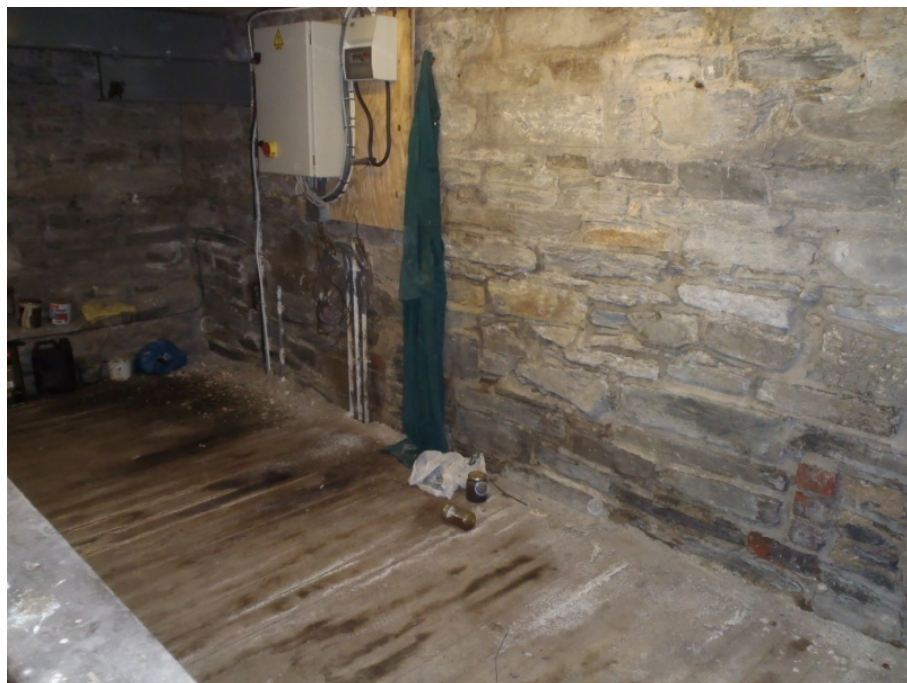
At this level the floor is finished with timber boarding (refer to photographs 9 – 10). There is some staining from water to the boards but they are in a sound condition except where the end grain abuts the walls. It would be sensible to cut back the boarding 38mm from the perimeter with a power saw in these locations.

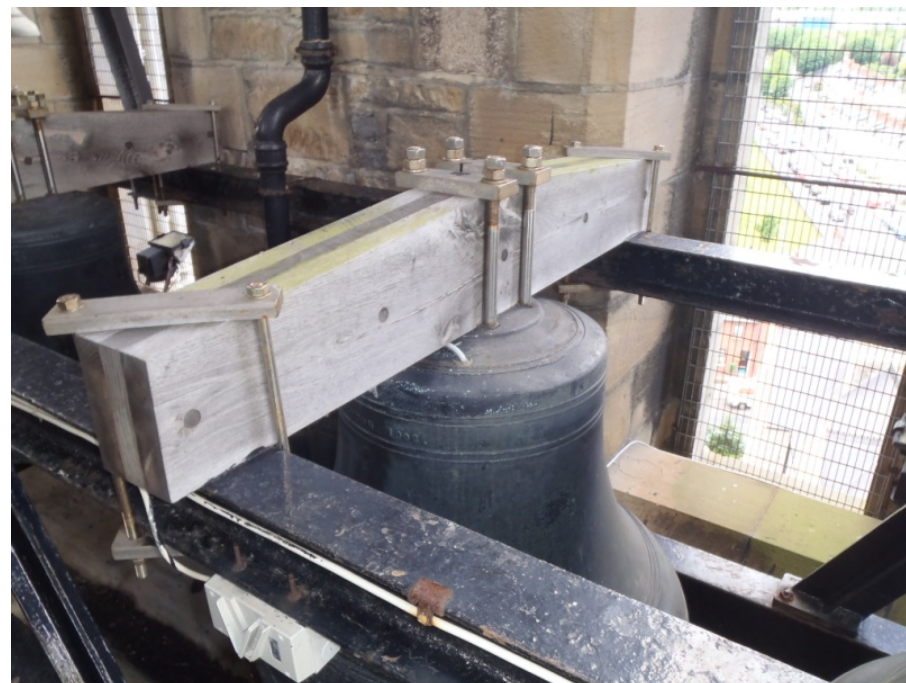
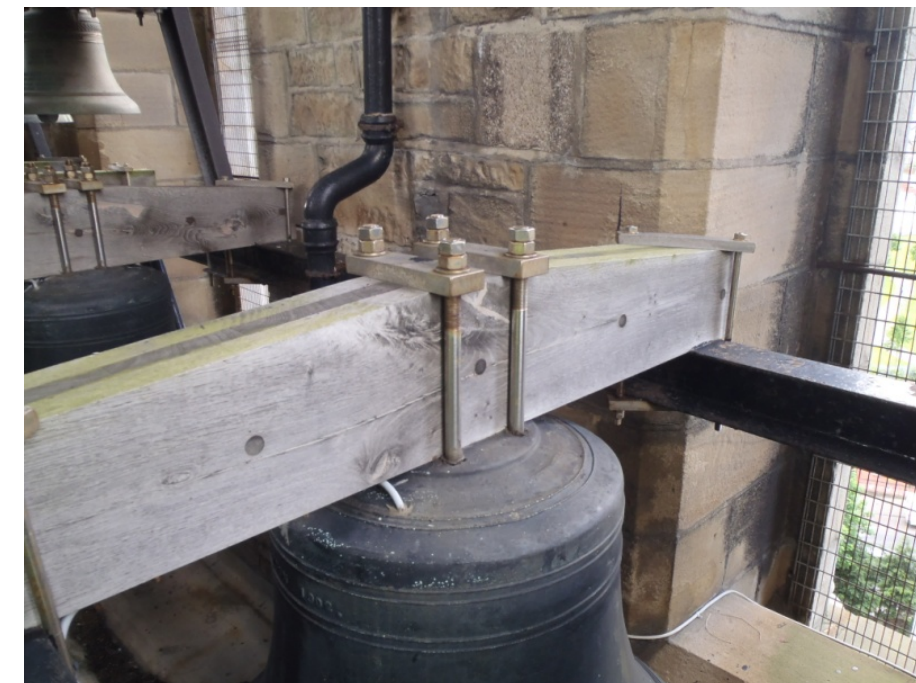
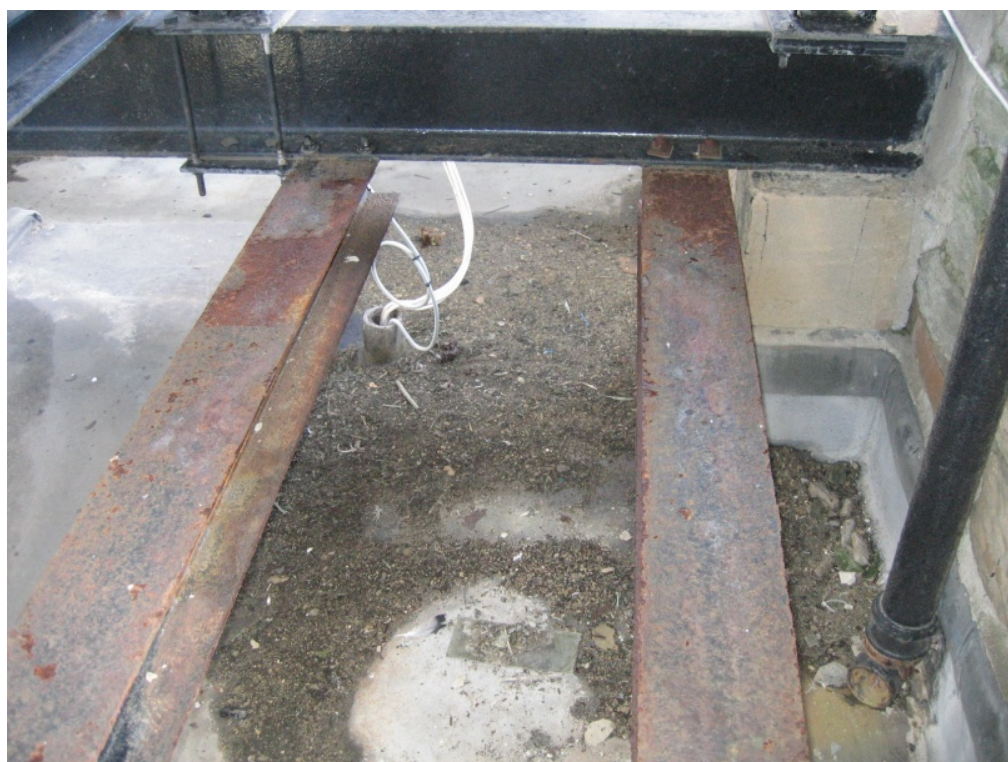
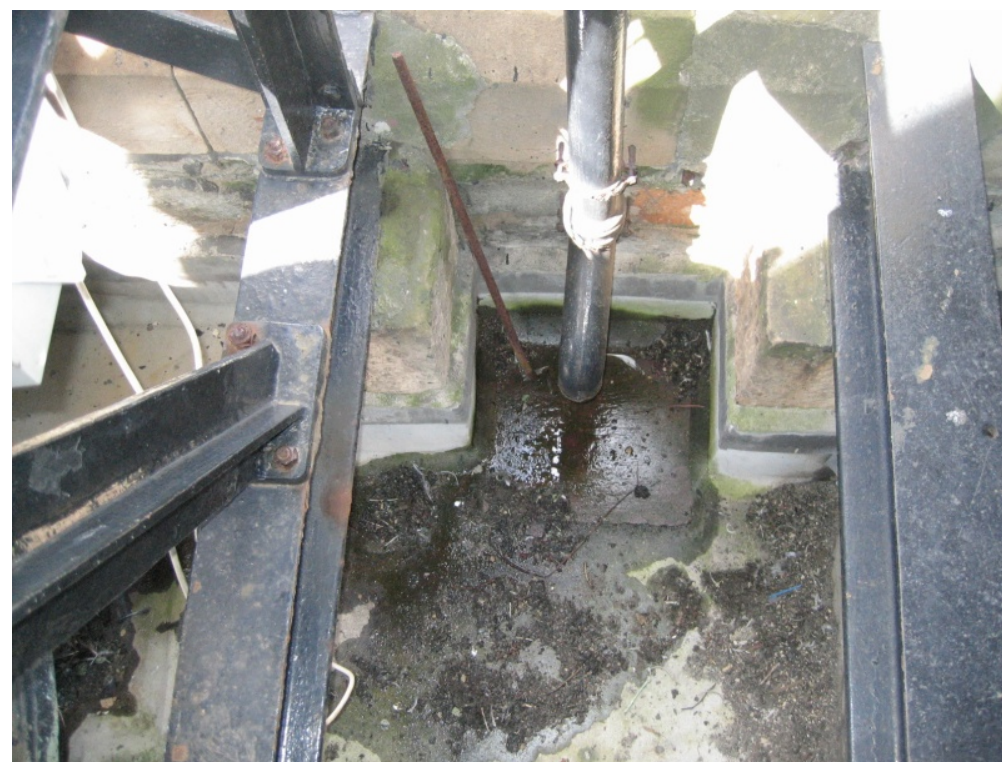
Although a lot of work has been done to the bells and the support structure in recent years the frame has quite a bit of corrosion present (refer to photographs 11 – 14).

The asphalt floor is sound (refer to photograph 13 & 14), however should have guano removed.

This steel frame needs to be cleaned down and painted with a proprietary paint system for exposed conditions such as Corroless Corrosion Control (refer to specification in Appendix B).

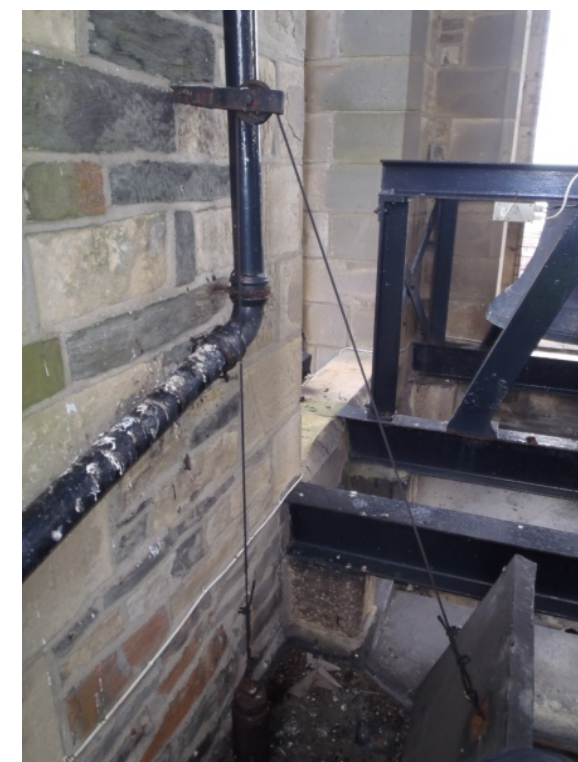
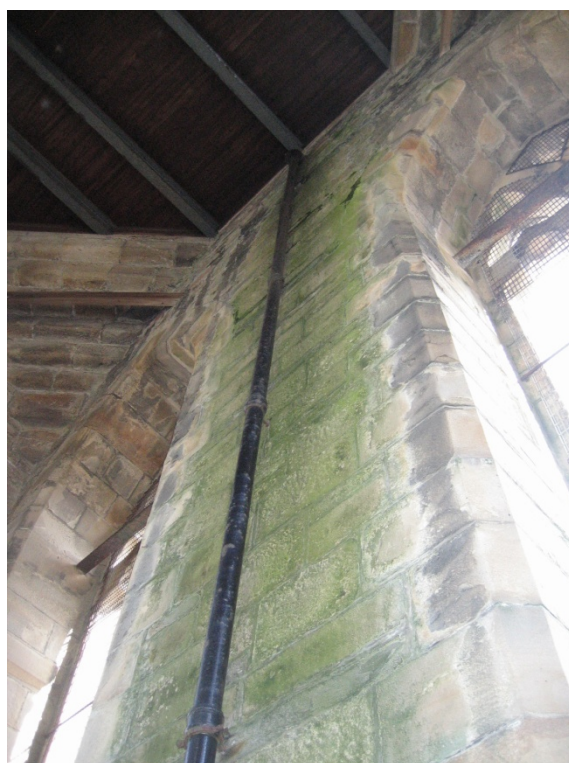
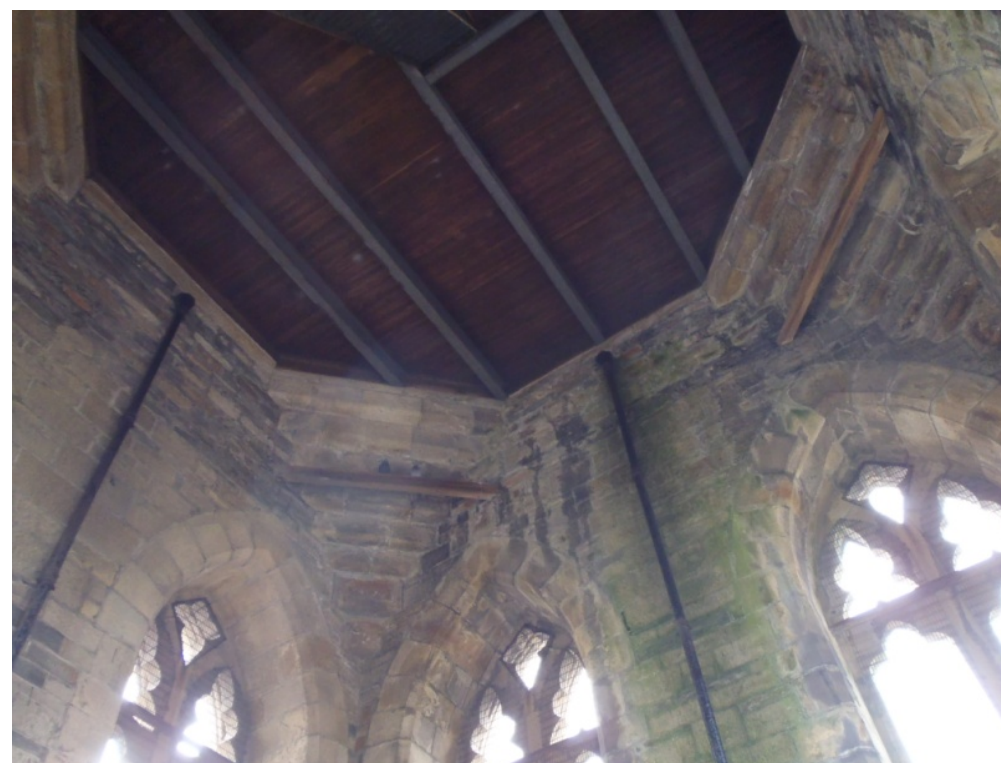
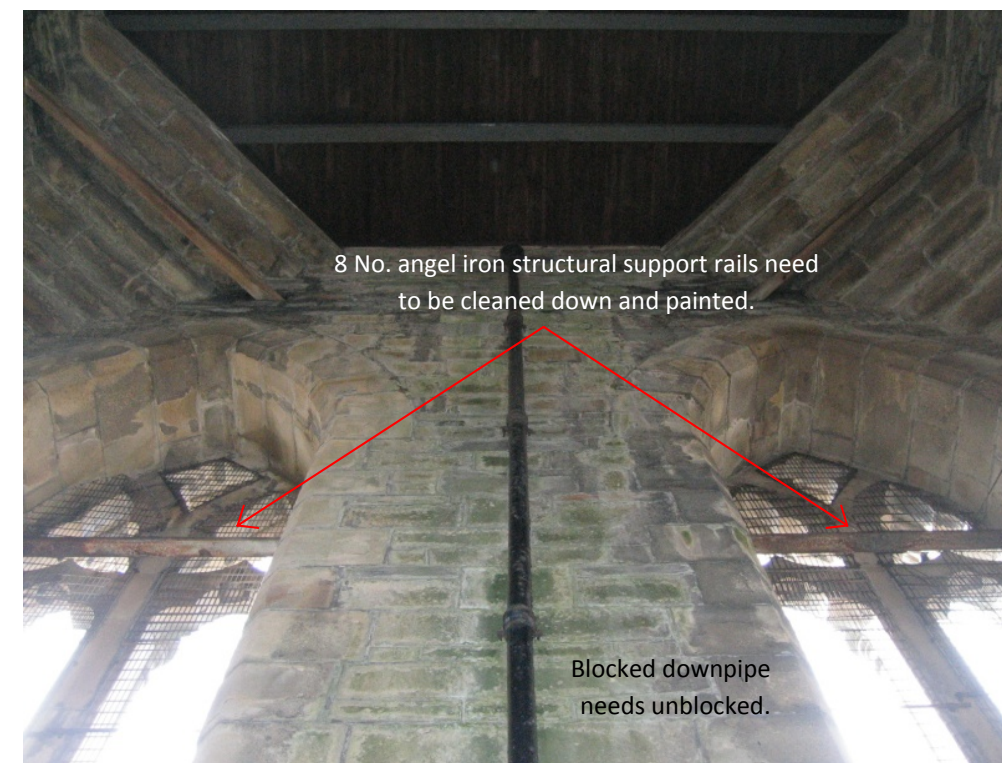
18

The cast iron downpipes in this belfry will also need cleaned down and painted (refer to photographs 15 – 18). This should be the same paint specification as in the paragraph above, details in Appendix B.

There is an angle iron structural support rail at each spring point of the Gothic windows (refer to photograph 18). This should be painted in the same paint specification as noted in 2.04, appendix B. It is noted on photographs 15 and 16 that there is green staining on the wall in the area of the downpipe. This is due to a blocked pipe and the water building up and coming out of the hopper and the collars where it joints. The pipe should be removed and blockage cleared.

8 No. angel iron structural support rails need
to be cleaned down and painted.

Blocked downpipe
needs unblocked.

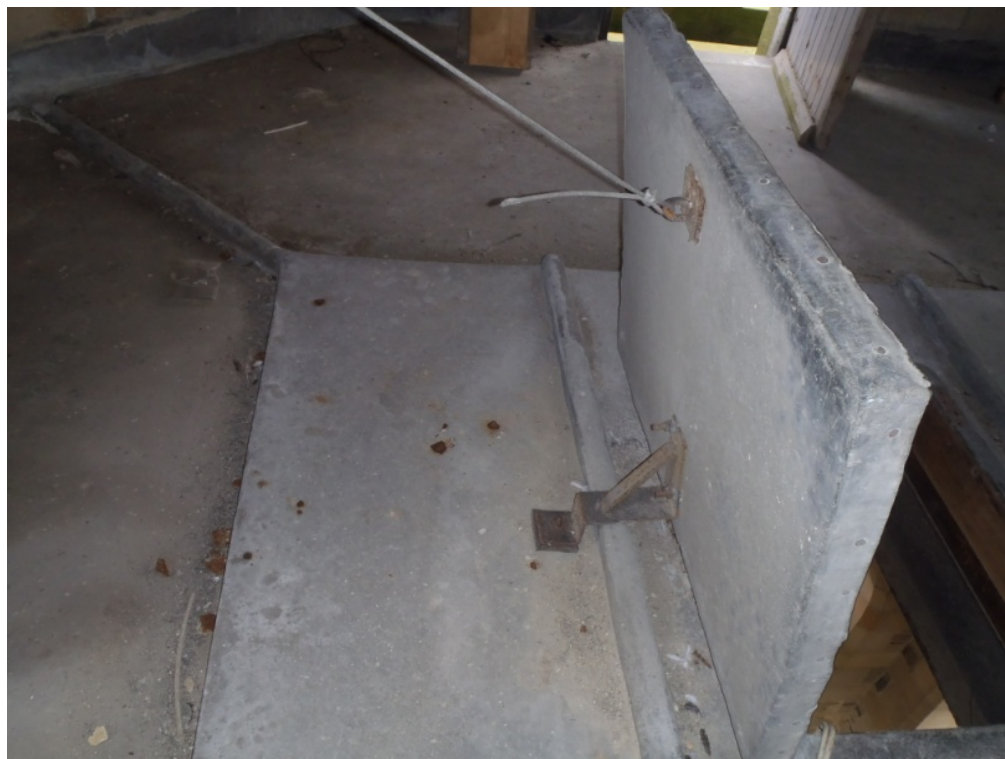
19

The floor to the upper spire parapet level is wooden boarding with lead covering. This is in a good condition (refer to photographs 19).

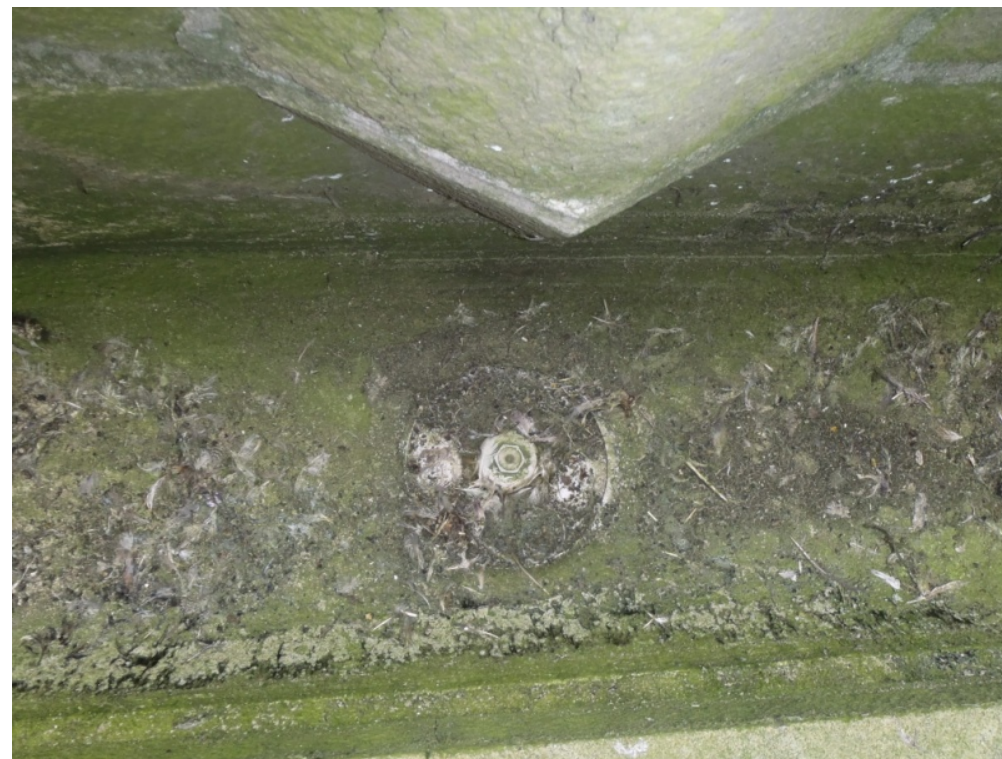
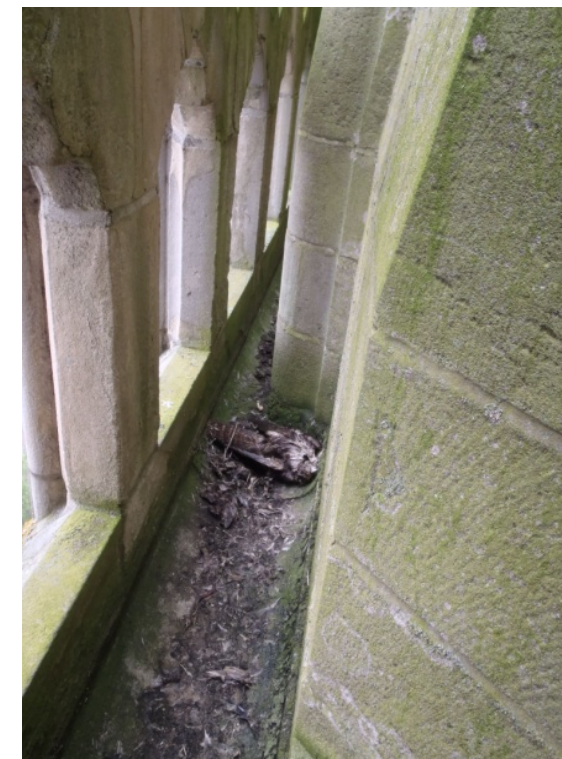
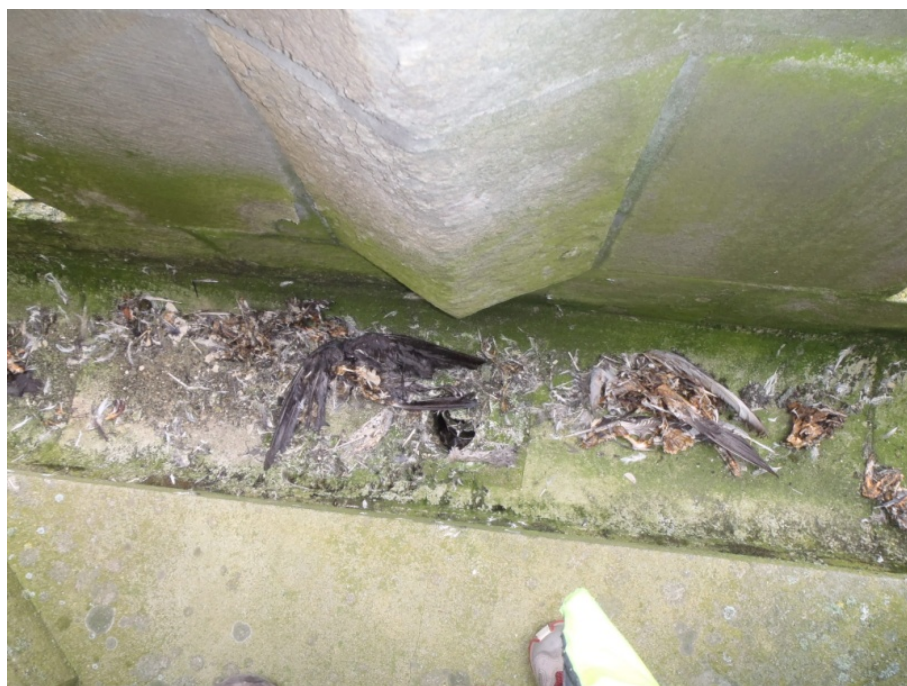
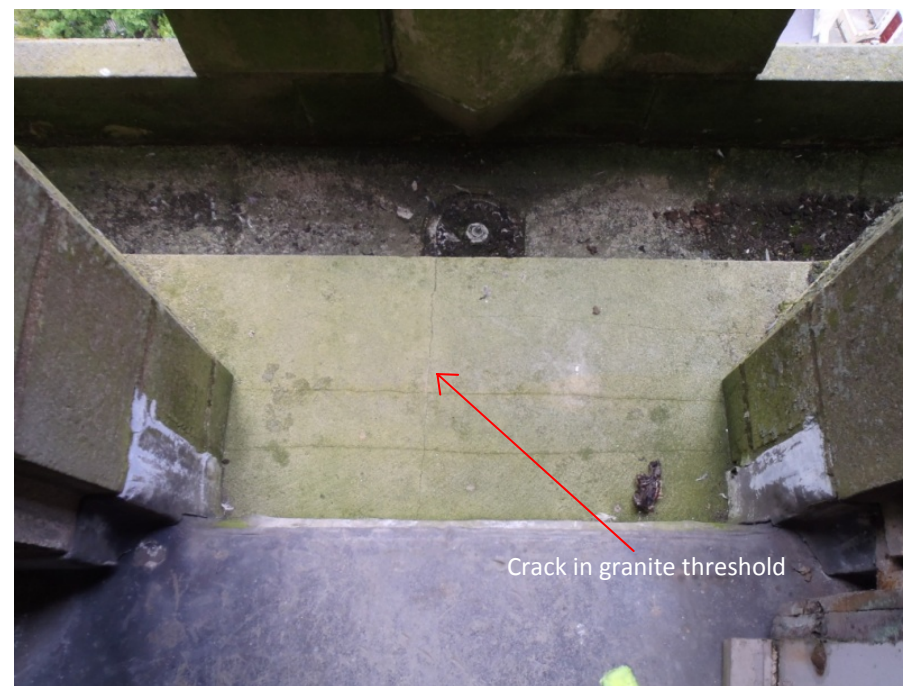
Externally at this level there is a decorative parapet on the granite wall. At the base of this wall a ceramic gutter goes round the spire. 'Sika' outlets have been bonded to these outlets which connect to the downpipes below. The majority of these outlets are blocked with dead bird bone skeletons and feathers (refer to photographs 20 – 23).

- The joints between the original semi-circular ceramic gutters are taking water into the structure.
- The current open size is around 60-65mm which is too small for the quantity of water that these gutters are taken in heavy rain conditions.
- There are cracks in the granite threshold stone at each of the doorway. This is again an entry point for water (refer to photograph 23).
- Appropriate guards need to be fitted to the outlets.

Given the above factors it would be prudent to increase the outlets. This may mean coring a larger hole or it may simply be that existing outlet holes can take bigger outlets. The gutter and threshold at each of the doors could be lined in liquid plastic (details in Appendix D). The surface needs to be clean and primed before applying such a product. The new outlets should have a patented guard.

However, maintenance checks should be carried out in this area every 6 months. It is likely that due to the unsafe condition of the current access ladder this has prevented maintenance to this area in recent years.

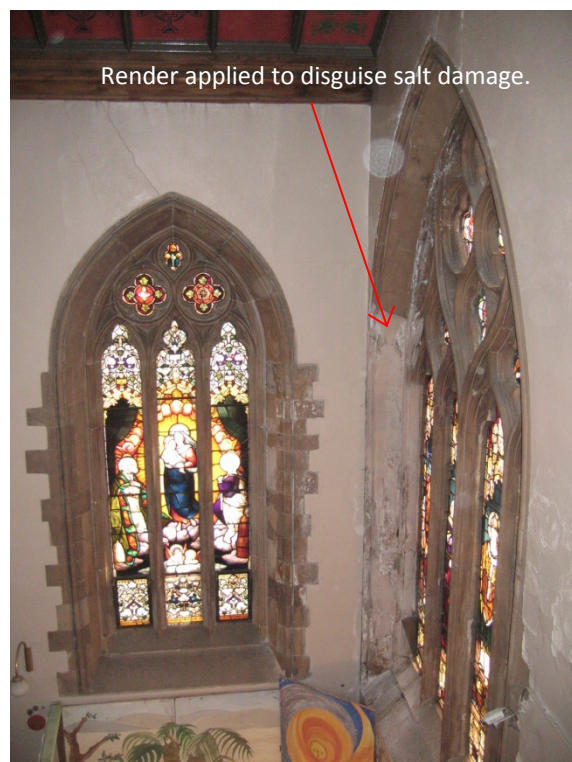
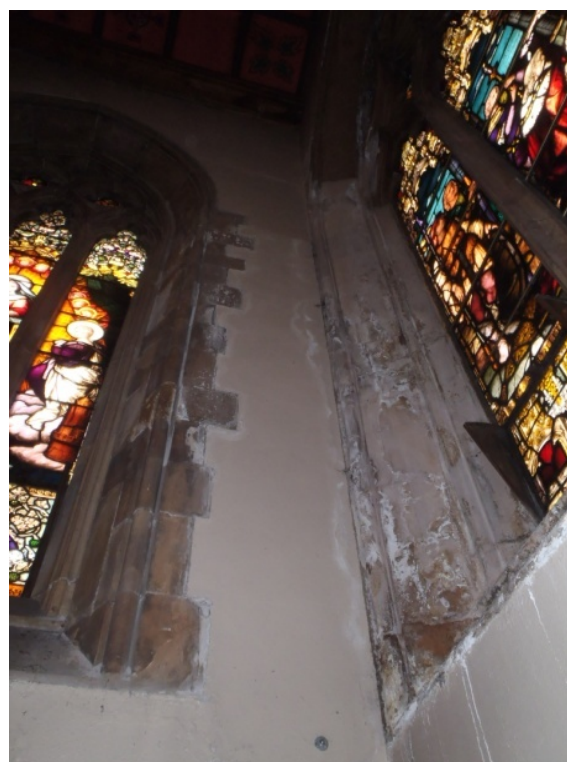
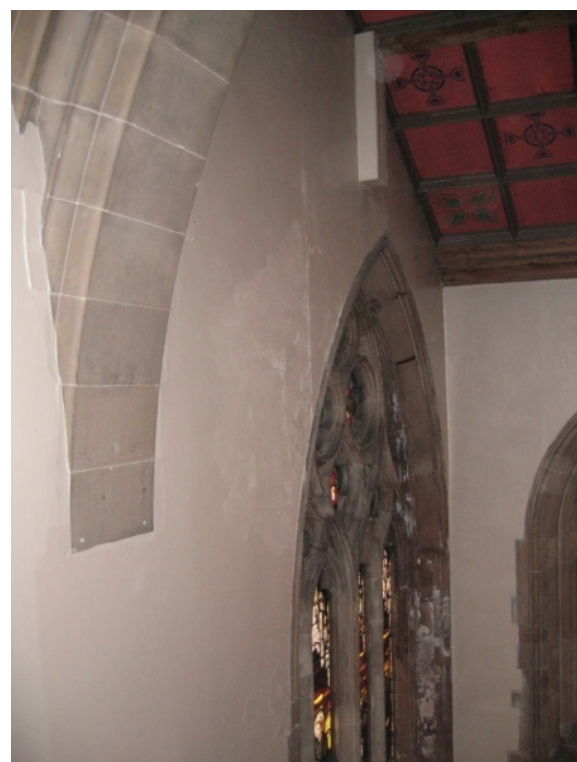
- 3.01 There is damp and salt damage to the reveals of St. Patrick's window and St. Columba's window (refer to photographs 25 – 27).

- **Internally** – the LHS reveal of St. Patrick's window from the cill to the springing point of the arch has a render applied finish (refer to photograph 25). This finish appears to only be 2-3mm thick.
We would suggest that a stone masonry company such as S. McConnell & Sons are engaged to redress these salts affected reveals with a mechanical diamond wheel disk and hand diamond pads. On completion of the redressing the two windows should be cleaned using Finalit No. 9 so it all ties in. S. McConnell & Sons are also the local supplier for the Finalit Range.

- **Internally** – the section of render that has damp or salts efflorescence needs to be removed. This should extend at least 1m beyond any visible damp or salts.
However plaster directly back on to a solid stone wall that is now heavy salt laden will mean that salts will break through the plaster in a few years. The surface needs to be clean and surface sprayed with Technoseal DPM, specification in Appendix E.

This product isolates the salts from the new render. The render is most likely lime however it has been re-rendered in the past and that may be done with a cement based mix. We would advise that it may be more prudent to remove all render from the ceiling down in the areas of St. Columba's and St. Patrick's windows. This will also avoid the patchy effect that usually appears when tying into existing plaster. The new plaster should be hydraulic lime plaster, refer to Appendix F for the specification.

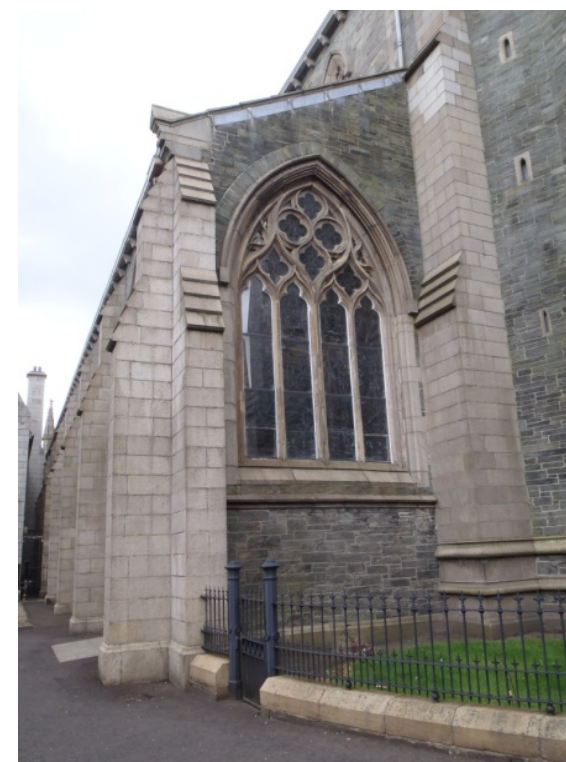
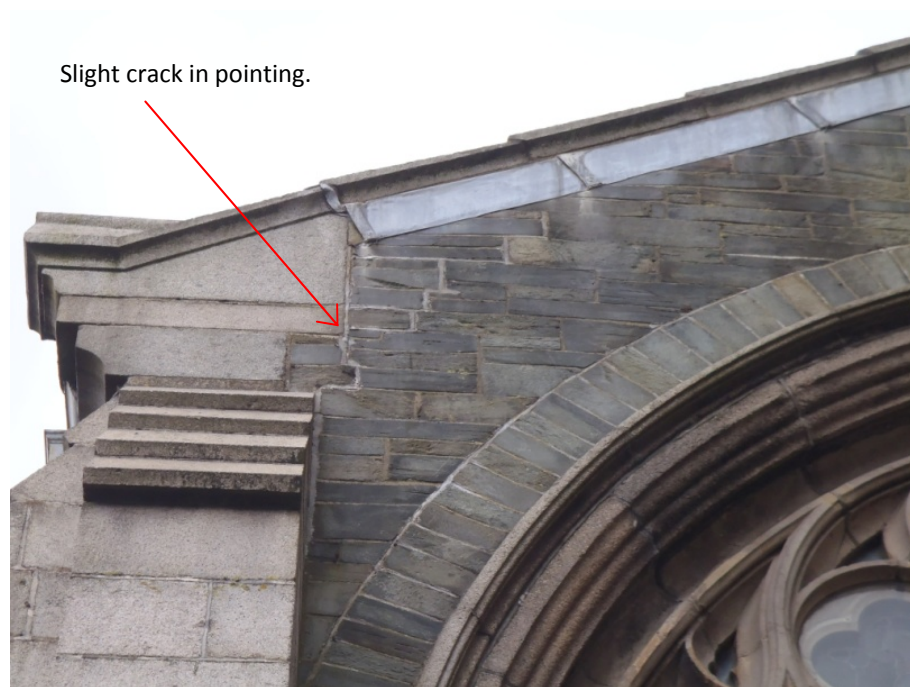
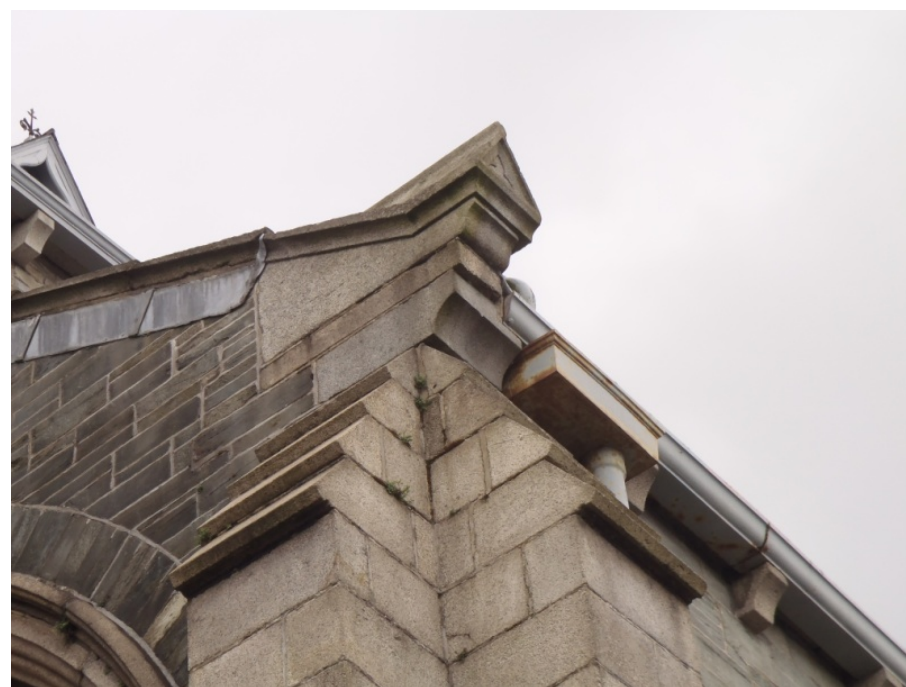
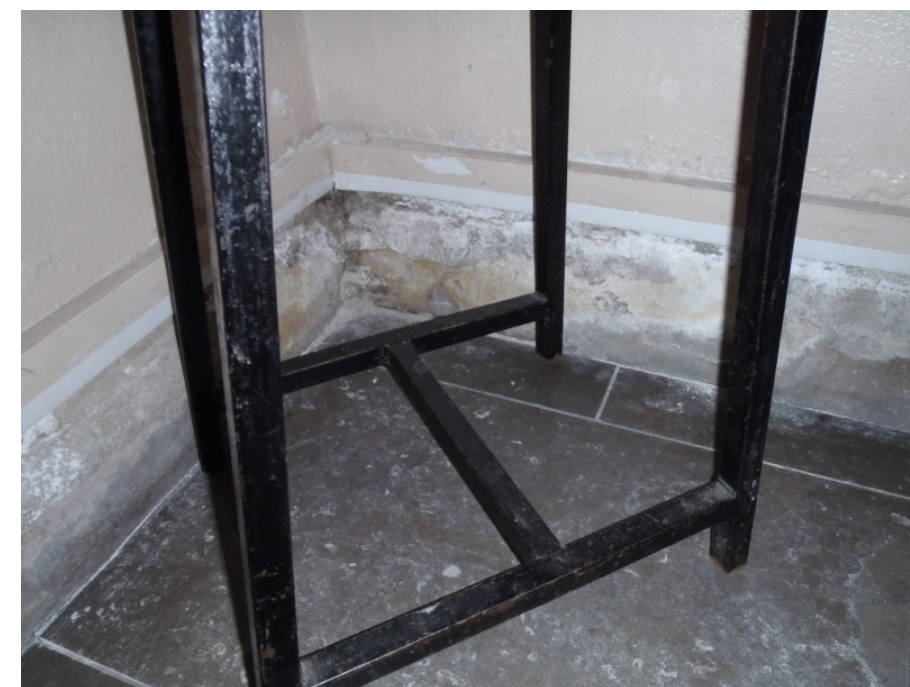
This has been an ongoing problem dating back to when the church was built and is due to how water is discharged from the copings of the mono-pitch roofs onto the outside corner buttress and window reveal (refer to photographs 28 – 31).

- There needs to be a new project specific detail formed at coping level. This will prevent water coming over the wall and spilling on to the corner buttress. We have been involved in designing these for other churches in the past.

- These corner buttresses should be re-pointed using NHL 5 hydraulic lime mortar.
- All open and retreated joints on the main walling of St. Columba's and St. Patrick's window need to be cut back to a minimum of 30mm and re-pointed in NHL 3.5 hydraulic lime mortar.

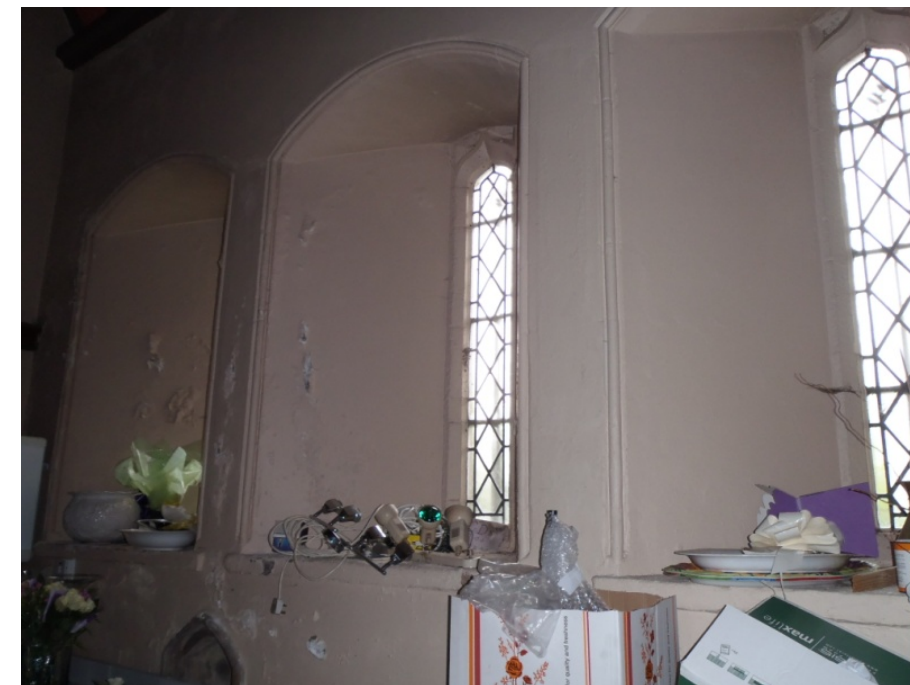
34

The salts and boast plaster are a result of moisture movement through the stone wall from the outside (refer to Photograph 34, showing salt efflorescence on the face of the stone in the same location as the internal salts).

It would be prudent to re-point this location on the external face in NHL 3.5 hydraulic lime mortar. It may be result of leaking joint from the gutter directly above. This should be investigated and repaired if required.
