**St. Eugene's Cathedral
Francis Street
Derry**

Condition Survey

July 2012

STONE CONSERVATION SERVICES
CONSARC DESIGN GROUP

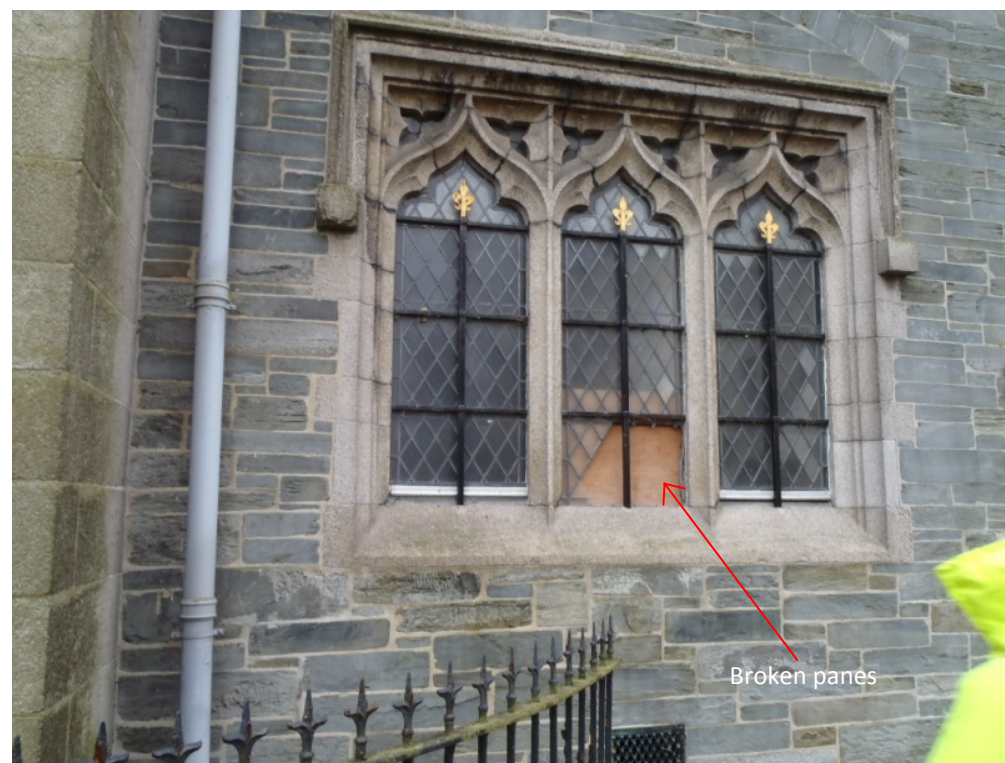
36

- 5.01 The rear elevation adjacent to The Last Supper window pane is broken and should be repaired (refer to Photograph 36).
- 5.02 There is a cracked cast iron downpipe beside steps that go into the vestry (refer to Photograph 37). This downpipe section needs replaced.
- 5.03 The cast iron downpipe that comes down and over the monopitched roof above the Sistine Madonna window has damp staining on the wall and a crack to the cast iron pipe that runs over the monopitched roof (Refer to Photograph 38).

Broken panes

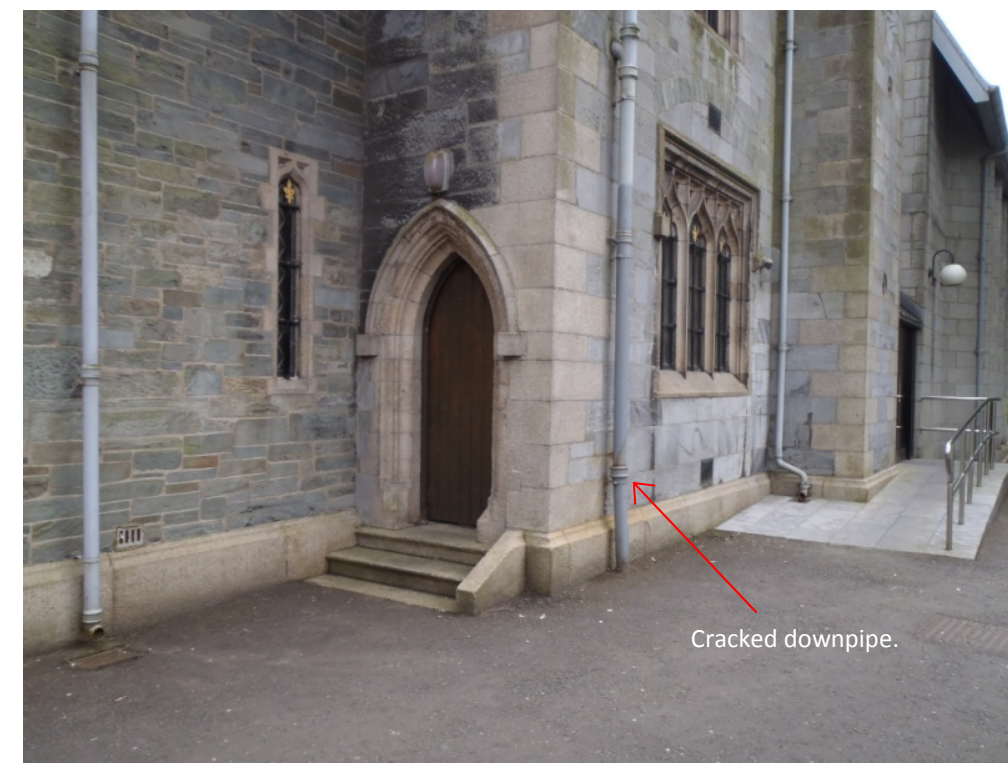
37

Cracked downpipe.

The pipe needs to be checked for blockages and cracked sections of the cast iron downpipe replaced.

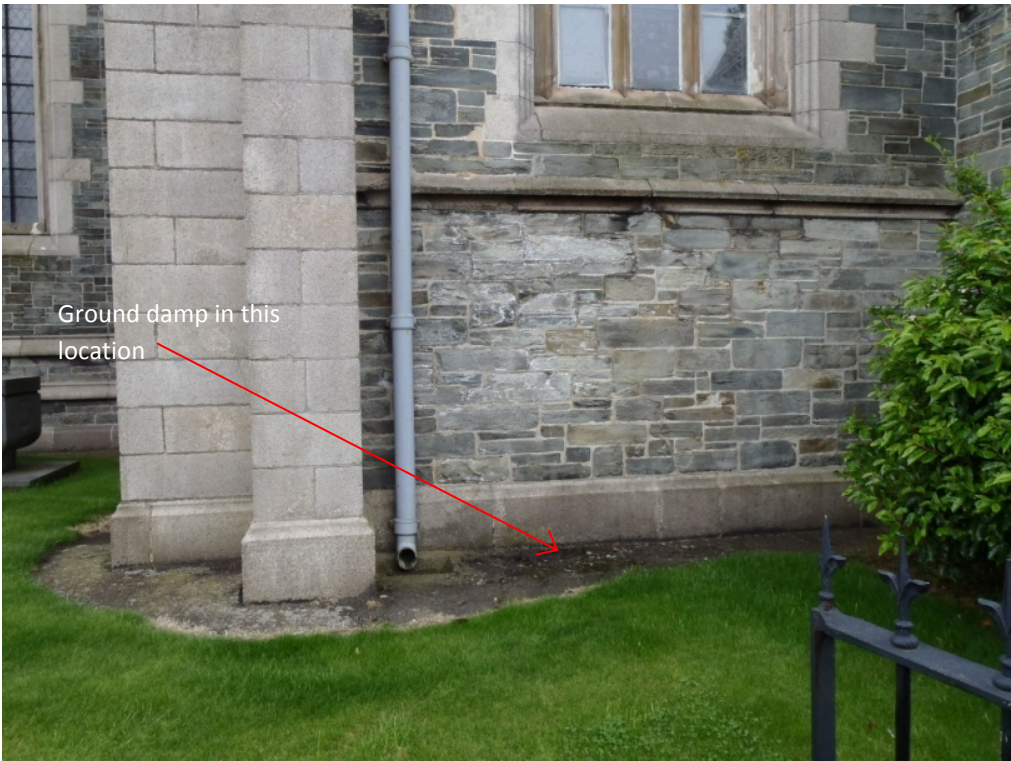
39

- 5.04 All external gullies need to be checked and if blocked cleared or repaired. It would appear from the ground below the Sistine Madonna Window that gullies overflows as the ground in this area is very damp (refer to photograph 39).
- 5.05 The solid stone chimney (refer to Photograph 40) above the vestry has no lead tray and therefore provides a path for moisture to the internal fabric of the church. The internal plaster in this location can be repaired as stated in Section 3.01 of this report. The chimney needs to be checked to ensure all joins are correctly pointed. If joints are good then a clear breathable water repellent such as Keim Lotexan should be applied as per manufacturer's directions, details in Appendix H.

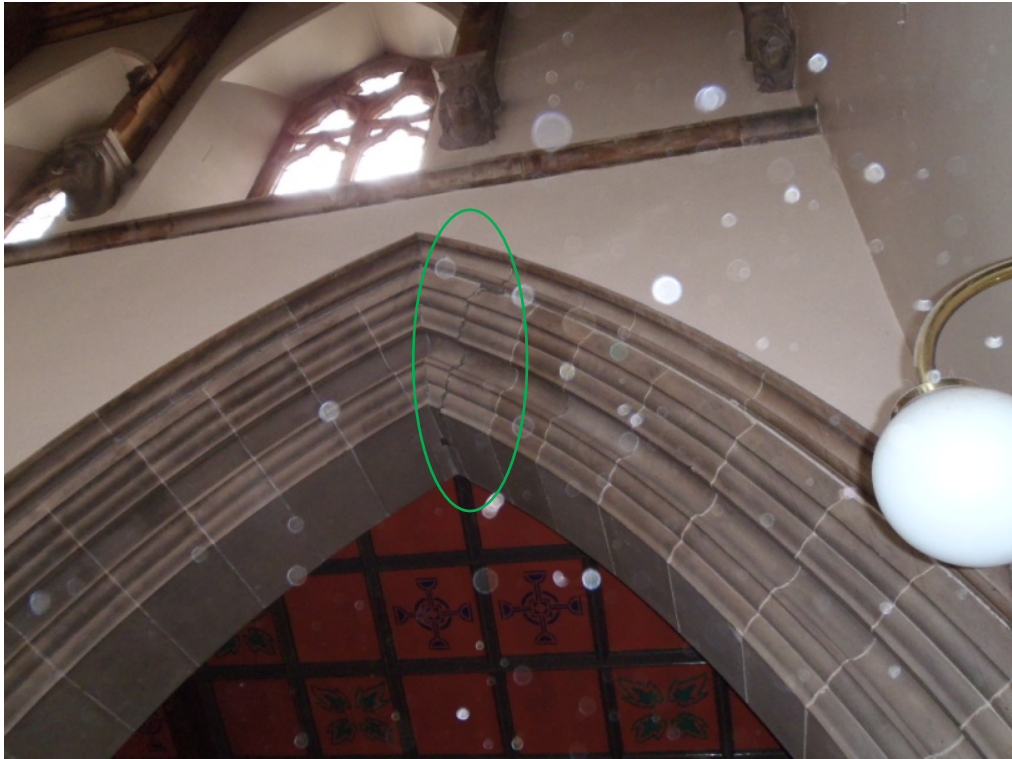
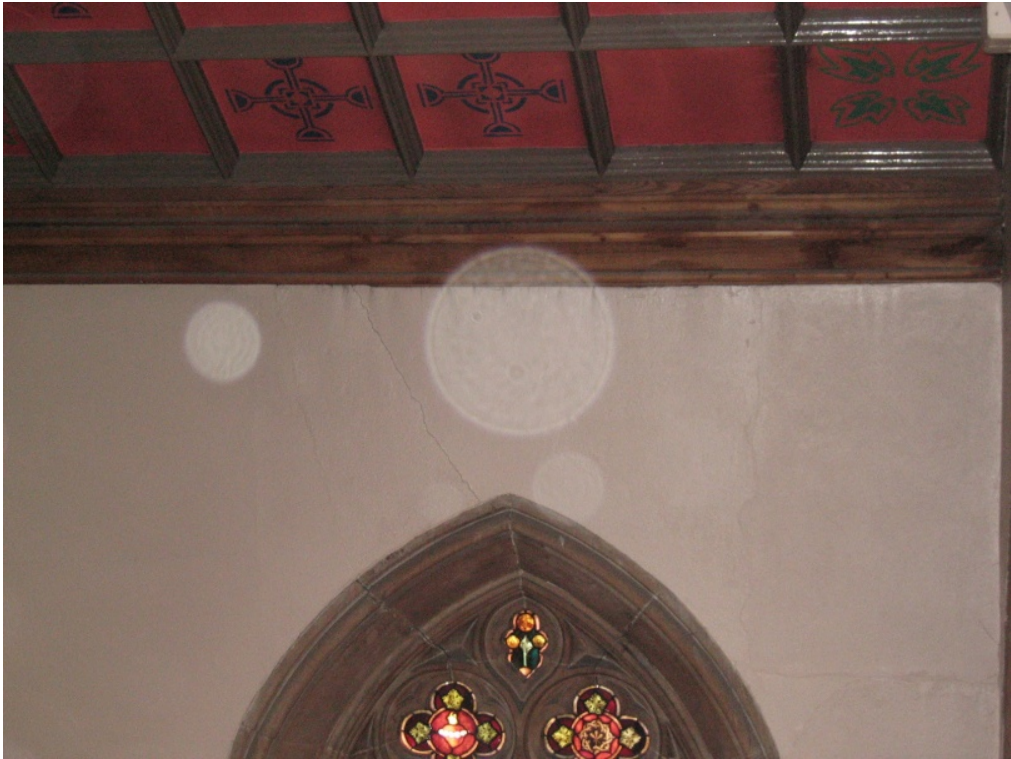
FIGURE 2

- 4.01 There is some evidence of structural movement within the church however this appears to be historic.
The movement is on the Gothic arches and above St. Columba's window (Refer to Photographs 41 & 42 and to Figure 2 for the location).

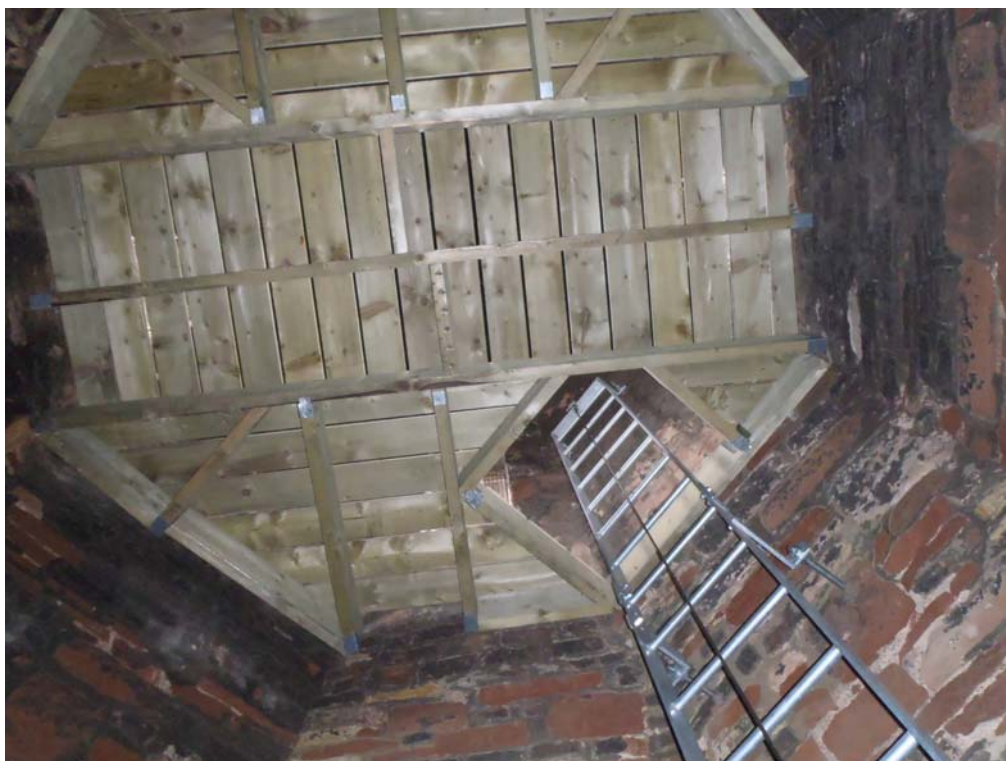
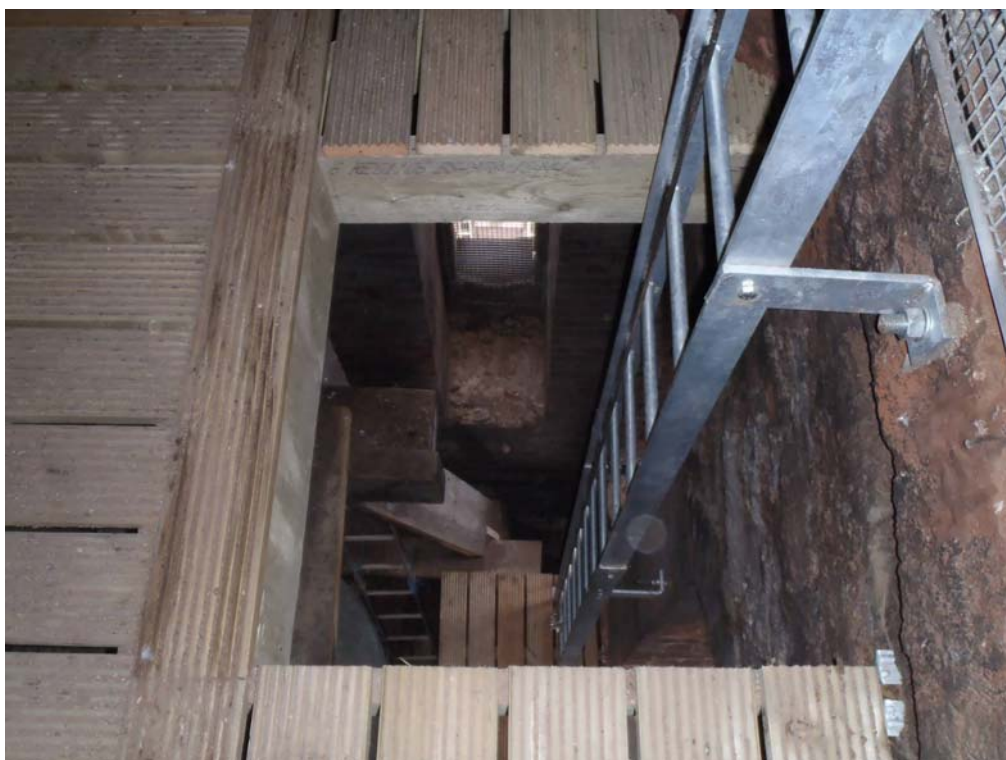
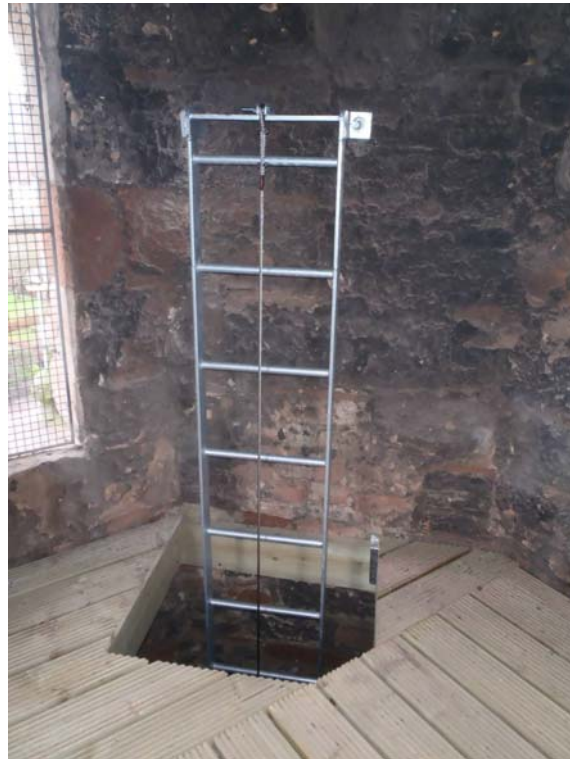
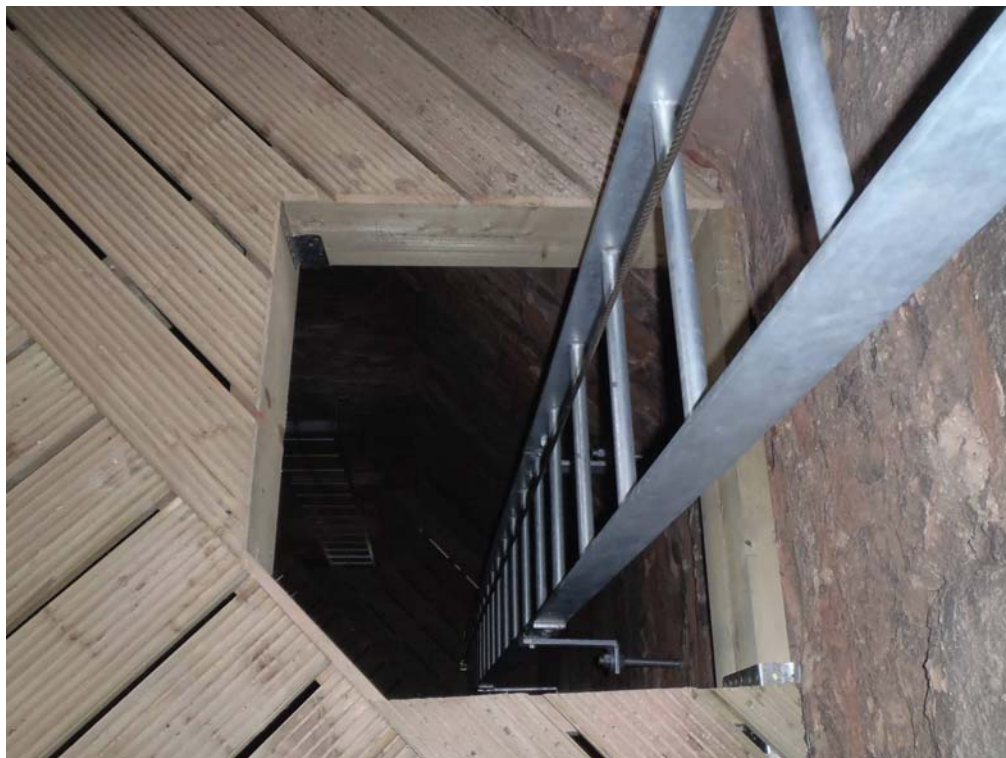
Appendix C
Typical Access Ladder Arrangement

This access ladder should be replaced with a bespoke galvanised ladder. The ladder will either have hoops to prevent falling or a failsafe stainless steel wire rope should be connected to a harness before climbing up. There will need to be a platform and short ladder installed to gain access to the current hatch or the access opening moved to directly above the new access ladder on the wall. Appendix C shows a typical new access ladder specifically designed by Consarc for another church.
