Completion of essential repairs and refurbishment at St Eugene's Cathedral

The aim of this project was to carry out essential repairs and maintenance primarily associated with damage caused by the entrance of moisture to the fabric of the building.

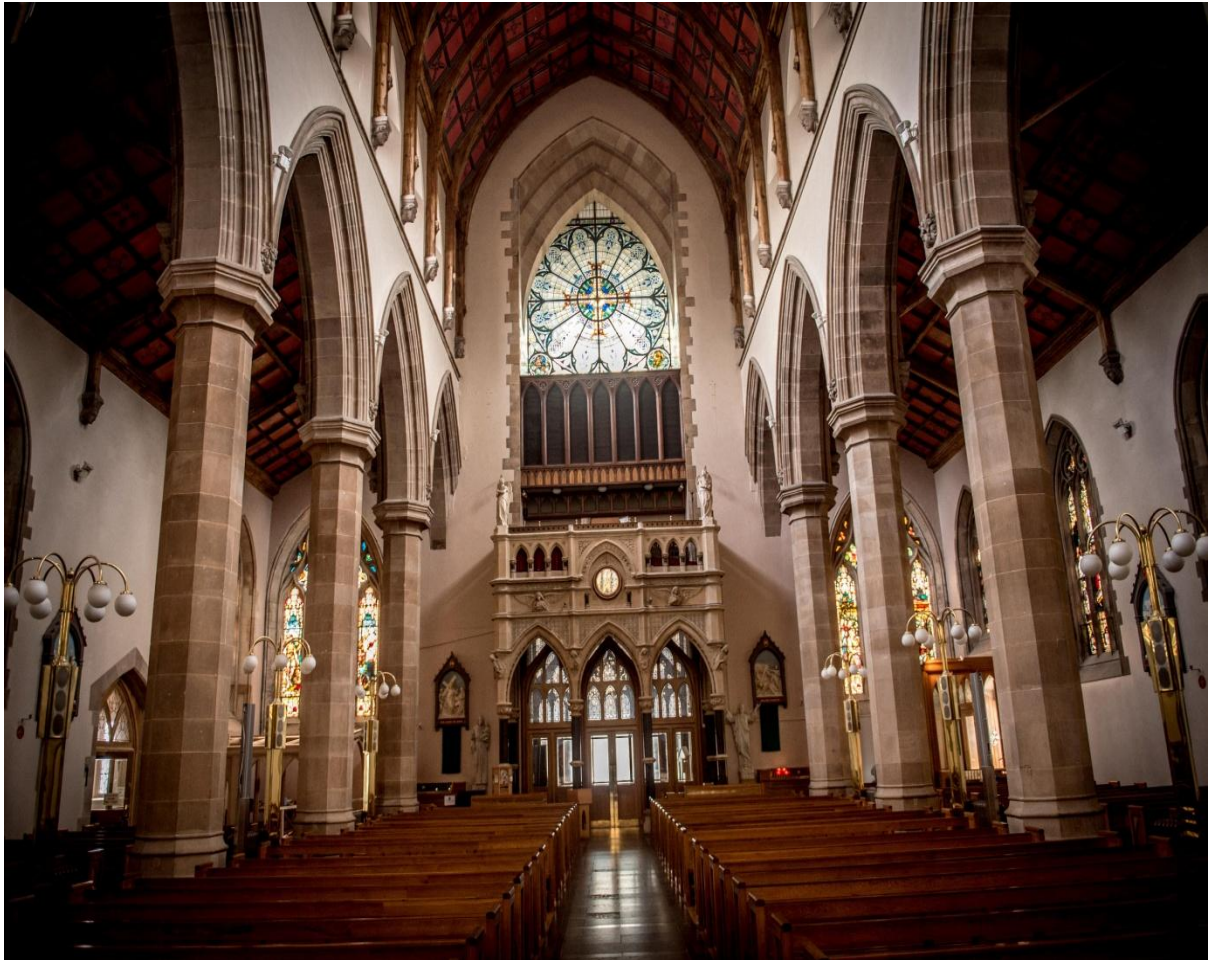
Nave Interior looking West

This is the incredible view enjoyed by the priests when celebrating Mass. St Patrick's window can be seen to the left, St Columba to the right. The Rose Window is actually internal to the Bell Tower.
